# SAFETY ALERT!

## AC Junction Box (ACJB) supply shorted to earth (Employee removing a Steel Wire Armoured SWA gland nut)

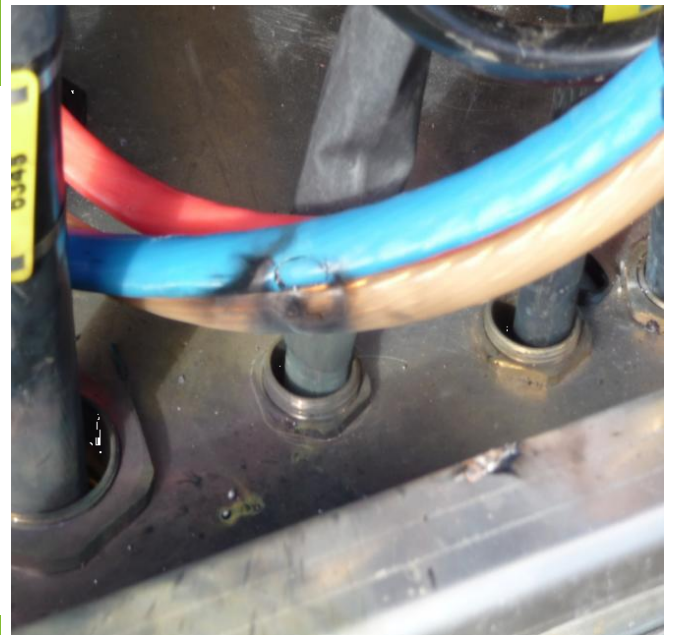
On 13 August, at Takapu Road Substation an employee was removing an isolated and redundant 400V cable from the ACJB.

In order to loosen the SWA lock nut, multi grips were needed as the nut is tight to ensure a good connection to the earthed gland plate.

When repositioning the multi grips the insulation has been damaged resulting in a short to earth. The grips did not slip from the lock nut.

- The employee did not receive a shock as the multi grips has a rubber handle approx. 5mm thick and the grips were in good condition, in addition he was wearing gloves that had a rubber underside providing additional protection.
- There was a short to earth but the fault current was not sufficient to blow the fuse.
- Ensure additional mechanical protection is in place when working adjacent to live cables in a confined area and hand tools could potentially damage the insulation.

The employee notified his supervisor and the cable was isolated repaired and returned to service.
