## Defective wiring insulation within panel trunking

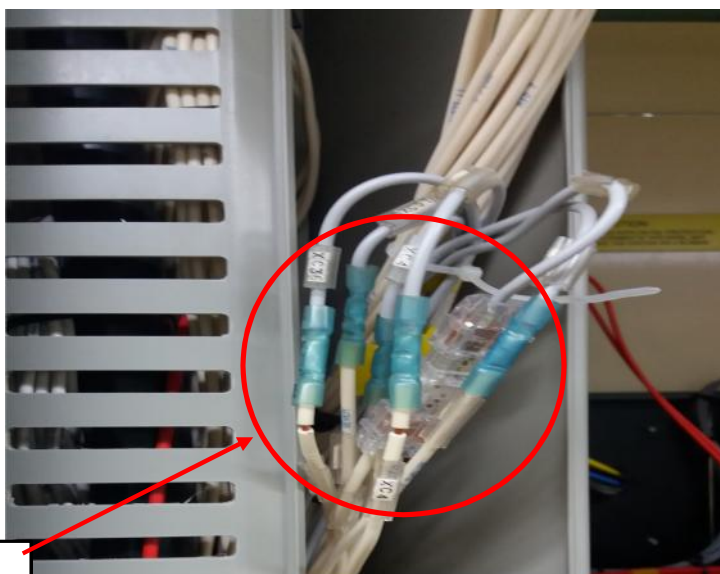
- During scheduled Manapouri Protection maintenance, wiring was moved in the panel trunking causing it to short out. This resulted in a blown fuse on a shared supply for the "GEN-I Trip" Circuit.
- Wiring in the panel had been previously stripped back and left, allowing the copper cores to be exposed (see red circle in photo).
- Further investigation identified that the crimp terminations were also not heat shrunk.

Wires with exposed live copper, and terminations not heat shrunk down.

- Work on the panel was stopped and NGOC informed of the blown fuse.
- Circuit traced and Gen I Trip cct isolated from Transpower protection circuitry as a precaution while the wires were reinsulated and the fuse replaced.
- Reported issues and event to management and incident report created.

- Never leave wiring in a poor or unsafe state as this will catch someone out in future.
- Terminations must be "made off" to a finished or completed standard as per the manufacturers specification.
- Maintainers need to be vigilant in checking wiring and equipment that they are working on due to possible previous poor workmanship or deterioration that may have created additional hazards.
