# SAFETY ALERT

**Subject:** Larch wood poles

**Date:** Friday 8 September 2017

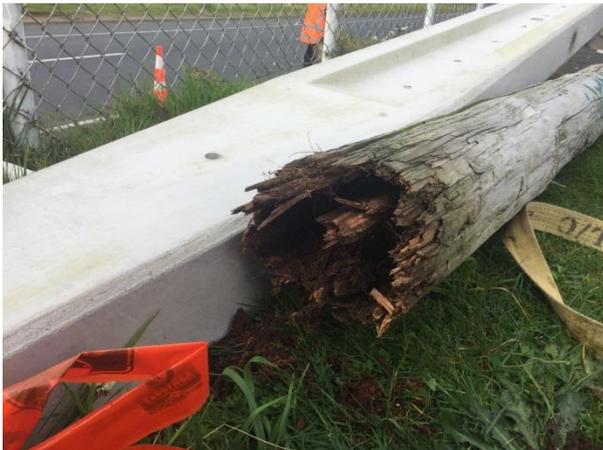
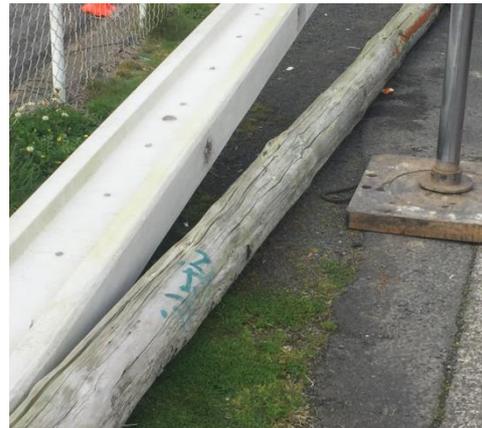
On Tuesday 05/09/17 a larch pole fell without any external force being applied.

This pole had been inspected 1 year previously and determined to be in good condition. Investigation on this pole post incident has determined that the pole had rotted from the inside out. Therefore while the outside of the pole appeared to be in good condition the inside was completely rotten.

Larch poles have the appearance of a soft wood pole with the expectation that the knots in the pole are randomly distribution rather than the ring distribution that is typical with a soft wood pole.

A new device will be used to determine the condition of all larch poles. This work will be completed by the end of November.

Until this work all poles that are expected to be Larch shall not be climbed, if access is required then the pole shall be accessed via EWP or the pole supported with a crane.

All other poles should be inspected as per SWP0304 prior to climbing.
