**Date Issued:** 21 November 2017

**ICAM 51:** Investigation 803718 - EWP Bridge  
Collapse Makarewa

**Risk Manager Incident number:** 803718

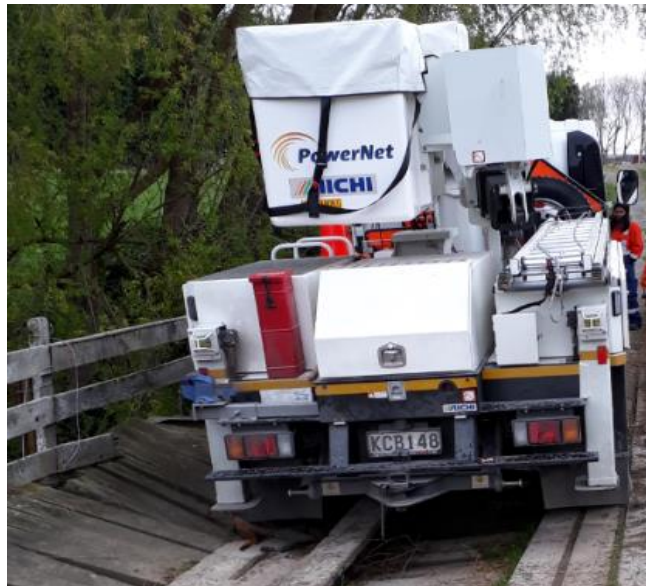
A PowerNet EWP faults vehicle was travelling to a customer fault and entered a Landowners property. There was a farm bridge on the private property that appeared to be in reasonable condition, the bridge traversed a river with significant fall to the water. The driver of the EWP failed to complete a risk assessment and inspection of the bridge prior to the crossing.

When crossing the bridge the weight of the EWP caused the left side of the bridge to partially collapse, the driver immediately stopped and instructed his two passengers to exit the vehicle immediately. The vehicle was extracted with two large cranes due to the instability of the bridge.

1. The bridge collapsed due to inadequate hazard and risk assessment. The driver of the vehicle will improve their use of risk assessment tools.
2. All field staff are reminded to use the PowerNet property access form when entering private property.
