SAFETY! ALERT!

9/3/2020

MHO in service equipment MAD encroachment update

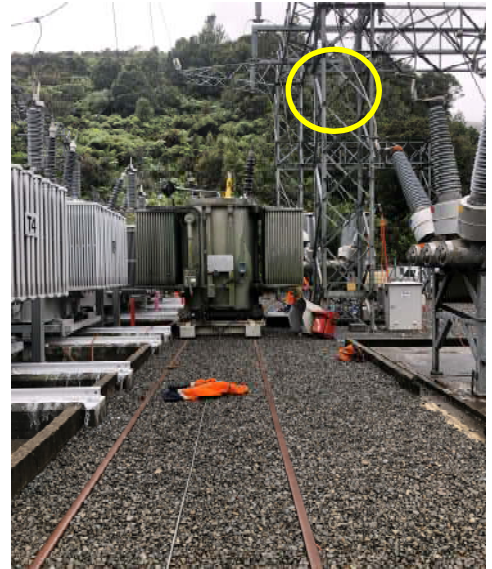
While work was being undertaken to move a larger relocatable Spare Transformer unit, the agreed Minimum Approach Distance (MAD) of 1.5M was encroached onto the in-service MHO-CB-102 supplying T4 (Yellow circle)

The investigation concluded this high-risk activity lacked suitable planning and task specific documentation to support the required work activities within the electrical corridor. This resulted in the encroachment of CB 102 (T4) not being a consideration in the planning and hazard management activities undertaken on the day. The team relied on historical transformer movements as the basis for establishing their job tasks and required mitigations.

The reduced electrical clearances (due to the transformers larger physical dimensions) was present on both sides of the traverser track electrical corridor, not just the northern side as identified by the team when planning and issuing the MAA documentation.

Essentially, the absence of an effective change management process and suitable task specific documentation led to this incident.

- Broadspectrum have developed an 'Equipment Movement Document Template'. This document provides the necessary steps and prompts to enable the job manager to robustly plan the equipment movement. The document supports the identification and management of the physical, electrical and environmental hazards associated with the task. This also provides the necessary handover documentation between the job manager and the team undertaking the works.

- Broadspectrum and Transpower are working through a 3D model survey of the MHO site, and trial for a future roll out to additional stations. This will enhance the physical and electrical hazard management activities in the substation environment.

- It is proposed to make this document a standardised template for all service providers, similar to the work authority and N security notices.
- Broadspectrum have reviewed their MAD process of identifying hazards in the electrical corridor. A MAA workshop has been delivered to maintenance staff, ensuring the process is understood and robust.

- TP & Broadspectrum to undertake a pre-emptive unit change, to release a smaller unit as the station 'spare'.
