FIRST ALERT

Maximo Reference: 113897

Failure to correctly earth Transformer HV

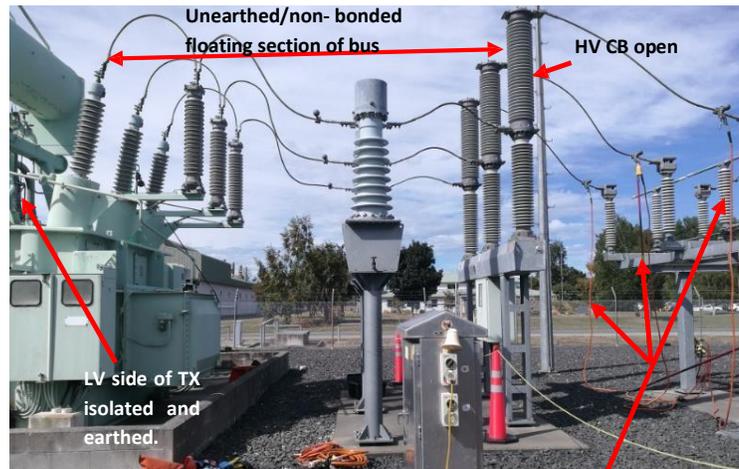
Tx, CT, CB, DS earthing layout

- During a maintenance outage a section of bus, transformer with associated circuit breakers and disconnectors were isolated and earthed. An access permit was issued.
- A prestart meeting was completed and a tradesperson and apprentice accessed the top of the Transformer inside the permit area.
- A section of conductor between the Transformer and the open HV Circuit Breaker was not bonded or earthed to the earth grid.
- The tradesperson and apprentice had not considered all safety aspects of their work before climbing on top of the Transformer.

Operator applied earths

- The work team stopped work and discussed the earthing and bonding necessary to access this section of transformer and bus.
- Rather than applying three temporary earths between the transformers and the CT, the work team decided to close, disable and tag the HV circuit breaker to create a continuous bond/earth to the section of bus between the transformer and the operator-applied earths.
- Follow up investigation has commenced.
- All de-energised equipment needs to be earthed and bonded as per the SMEI rules and Transpower Service Specification TP.SS 07.24 [Worksite temporary earthing and bonding in HV switchyards](#)
