Safety Notice

Issue 2 | Rev 1 | February 2024

SAFETY NOTICE – Missing T brackets or bracing on poles with transformers.

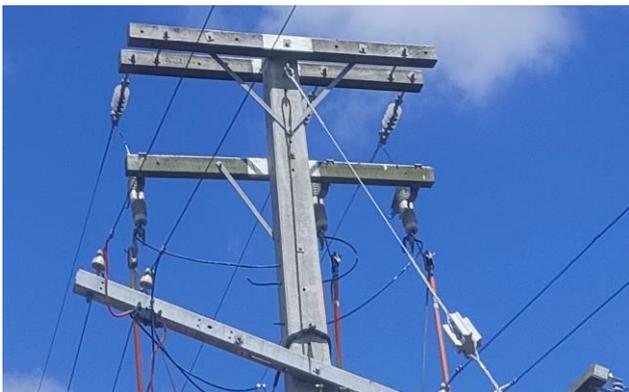
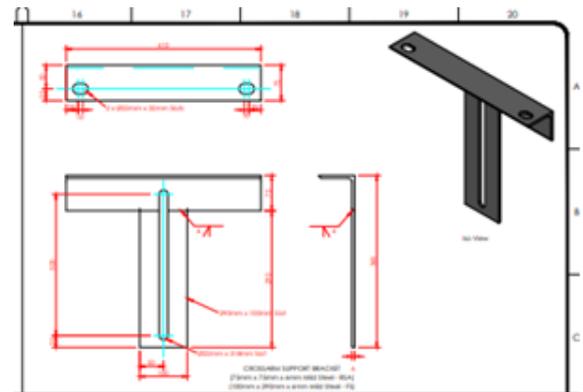
Background: when steel cross-arms were introduced, the two angle braces which had been fitted to wooden crossarms were removed as directed on poles with transformers.

An issue with the crossarms tilting was identified and a directive was put in place to install a T bracket or bracing to prevent the crossarm tilting when the transformer was unbolted.

The problem lies with crossarms, transformers fitted in between that change from angle brackets removed, to the directive to put in T brackets.

It is not known how many of these crossarms, transformers have no angle bracket or T bracket fitted.

- **Always check the crossarm has a T bracket** or some form of bracing before removing the transformer.
- Install a T bracket or bracing if missing before removing transformer.
- Inform Powerco of the install.
