Temporary Tower Incident

EVENT

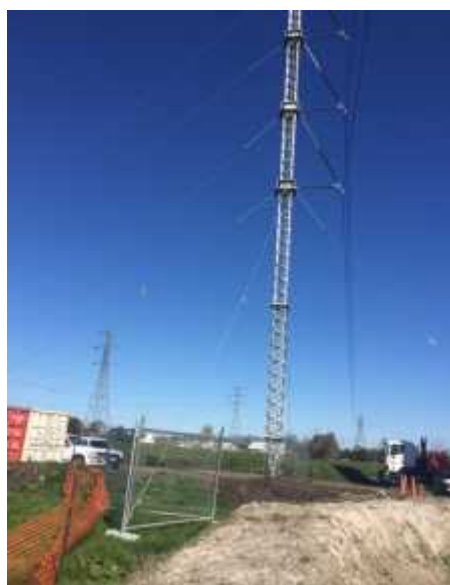
On Wednesday 17 August a Line worker was seriously injured when a temporary tower structure (Lindsey tower) fell.

The conductors were being removed from the temporary structure at the time in preparation to transfer the conductors to a newly installed permanent structure.

The worker who was in a work position at the top of the tower fell with the tower. He suffered multiple breaks to both arms and a leg. Following surgery he is in a stable condition in recovery in Waikato Hospital.

Investigations are underway to determine the cause of the incident.

- Until further notice Lindsey structures are not to be climbed.
- If temporary (Lindsey) structures are to be deployed work methods shall be designed to prevent workers from ascending the structure.
- Secondary holding mechanisms (safety rigs) are being installed to the guy wires on the remaining Lindsey tower at Ruakura.
