Ice Jacking on Compression Fittings

Quality Alert REF No: 2018-018

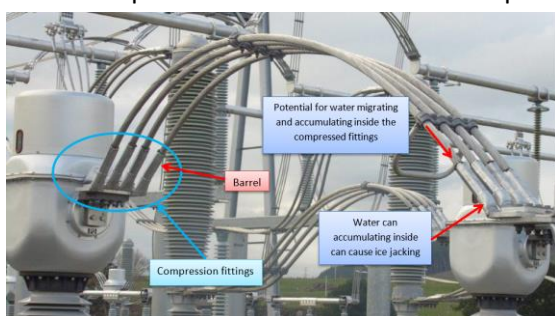
Transpower field audits are identifying line termination compression fittings/lugs are still being installed without the required 3mm drilled drain hole at the bottom of the end facing upwards, this allows potential for ice jacking. Ice jacking is caused by the capillary accumulation of water inside the termination end and the water expands when it freezes. After repeated occurrence, the material stretches to the point where it splits.

Figure 1. example of upward facing termination compression lugs

- This phenomenon is known to Transpower and a 3mm drain is required to be drilled at the base of all barrels installed where water can migrate and accumulate inside the fittings. This recommendation is documented in the Transpower service specification TP.SS 02.16 Appendix D, Clauses D1.15.

Joints at risk of ice jacking due to the accumulation of water (e.g. dead-end or jumper compressions with the mouth facing upwards) must have a 3mm drain hole drilled through the lowest point of the joint sleeve just in front of the compression zone. The location and orientation of the hole is shown below.

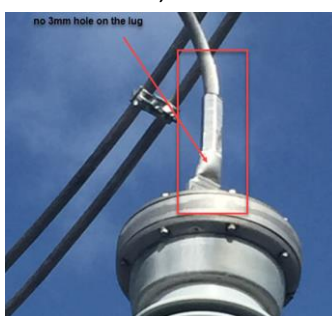
Figure 2. Example of lug with no 3mm hole

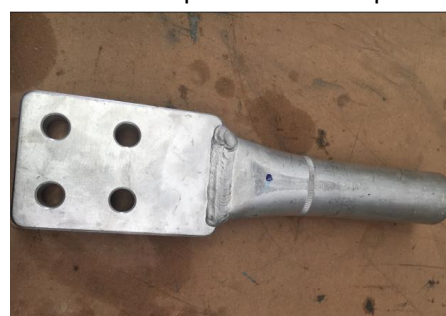
Figure 3. Example of lug with correct 3mm hole
