## 110 kV overhead line Crane Strike

### WHAT HAPPENED?

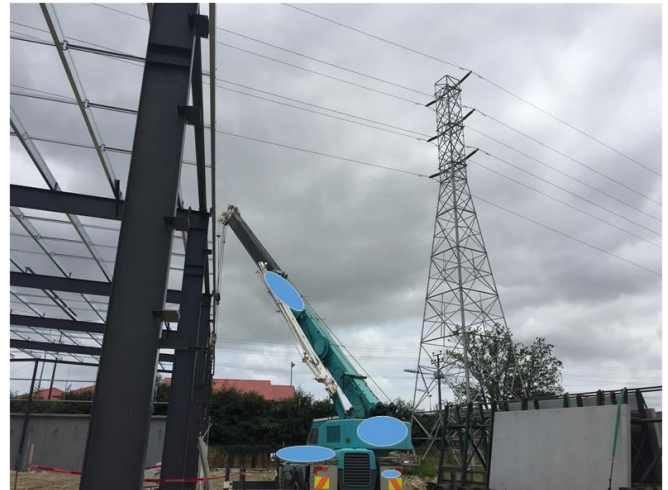
A crane was lifting concrete panels into place during the construction of a building underneath a Transpower 110kV transmission line.

While manouvering one of the panels into place, the crane's boom made inadvertent contact with the bottom conductor wire of the transmission line. This resulted in the dogman who was guiding the panel receiving a severe electric shock, throwing him backwards onto the ground.

- Work and operation of machinery around transmission lines must meet a minimum approach distance of 4m from the conductor at all times as set out in NZECP 34. A "WARNING, KEEP CLEAR OF POWER LINES" notice must be fixed near the operator's position on the machine. For more information on managing risks, see the WorkSafe information sheet on Working Near Overhead Electric Power Lines.
- The potential for loss of life due an event like this is extremely high.
- Failure to maintain the required minimum approach distance resulted in significant damage to the crane as well as the truck located in the vicinity.
- If you observe any unsafe work near transmission lines, please contact Transpower immediately on 0800 THE GRID.
