# FIRST ALERT

Date: 30/08/2016

Maximo Reference: 93492

## MHO-PKK Dismantle – Induction Electric Shock

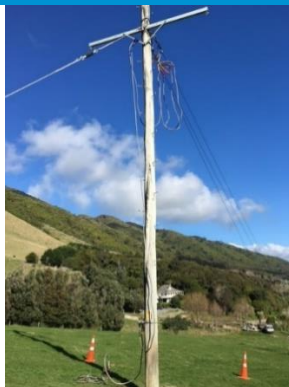
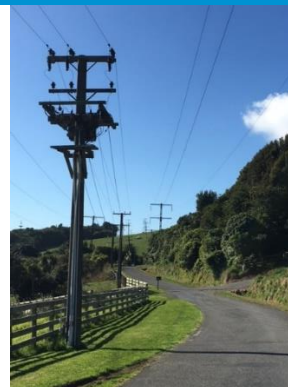
While a lines crew were working to cut and remove de-energised conductors on the MHO-PRM dismantling project an employee (working aloft a pole) received induction electric shocks.

- Ductor testing confirmed high resistance levels in the system due to the copper oxide on the surface of the conductor, the contamination of the head clamps with this oxide and the cleanliness of the driven earthing plate/rod.

- Service Providers (both Management and on the ground Work Crews) must ensure that all head and tail clamp surfaces are thoroughly cleaned as part of the earthing process in line with industry best practise. In addition, copper oxides should be removed from the surface of aged copper conductors prior to application of head clamps. The need to clean aluminium conductor is less apparent, but currently being investigated.

Changes will be made to TP.SS 07.23 and 07.24 to better reflect the importance of cleaning earths, conductors (both copper, ACSR GZ/AC, AAAC, SC/AC/AL) and any other surface which tail clamps are applied to.
