## Coupling bolt fell from Crane

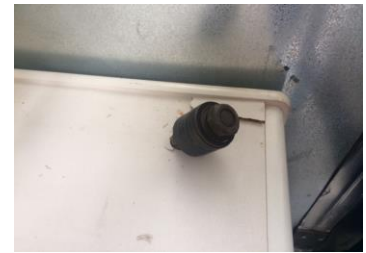
During a standard operating test of the Islington Crane, a coupling bolt was found embedded in the top of a storage table below the crane. The bolt had fallen from the crane some time earlier. The crane was last certified in January 2018. The bolt dropped from a height of about 8m. While hard hats are worn when the crane is in use, a person standing below could still have been injured if they had been struck by the bolt.

Vibrations during operation of the crane caused the coupling nut to loosen over time. Eventually, the nut came completely off, and the bolt came free and fell out.

- The crane was isolated, and the incident was reported to Transpower.
- Service Provider located the missing nut and reinstalled the coupling bolt.
- The other coupling nuts were checked for tightness.

- All nuts should be tightened to manufacturer specifications.
- Paint pens should be used to mark the position of nuts when tightened. This provides a reference for future inspections.
- The incident reinforces the importance of wearing hard hats when the crane is being operated.
