Date Issued: 22 November 2018

Incident Title: Copper Link Defect

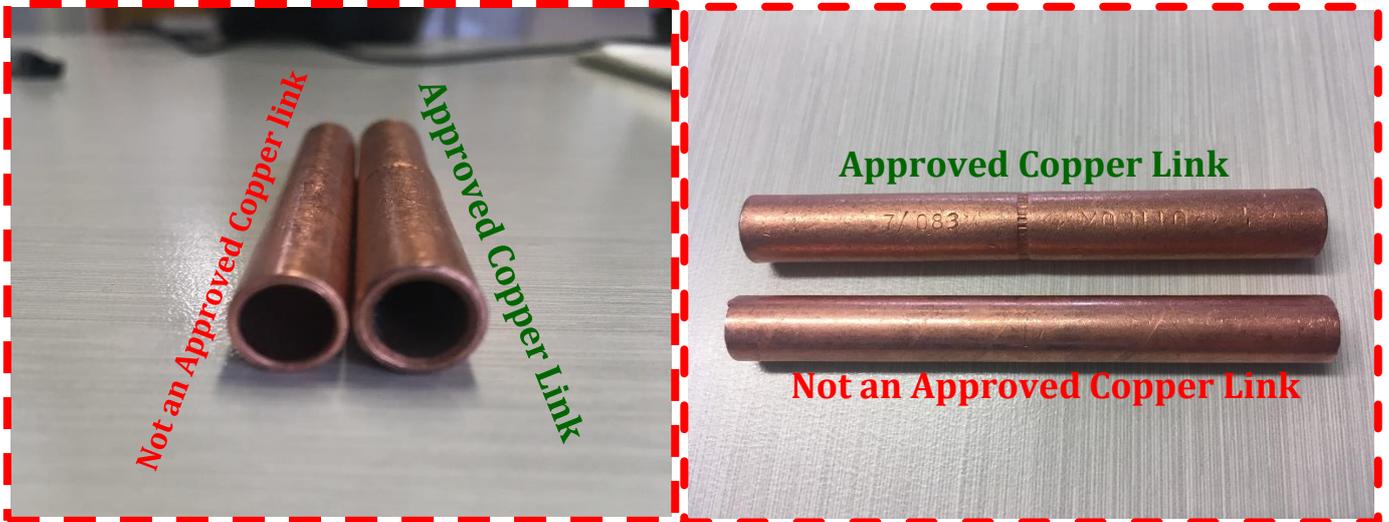
It was found that a box of 7/083 Copper compression links from the supplier had some irregularities in their sizing and product type. The internal dimensions are correct but the wall thickness is inadequate for an effective compression.

If the non-approved copper compression link is used to complete an electrical connection there is a risk of conductor failure, this could pose a risk to our people or members of public.

1. Ensure **ALL** links are thoroughly checked for suitability prior to installation.
2. If no identifiable size marking is visible **DO NOT** use the link.
3. Do not throw a non-approved link away. Take the link back and report to your supervisor so it can be documented and returned to the supplier.
4. Check all jobs where it is suspected that these links may have been used and advise your leader immediately.
