POWERCO

ISSUE No. 002
November 2017

SAFETY NOTICE- Operation of ABB SDAF Series 2 Switchgear

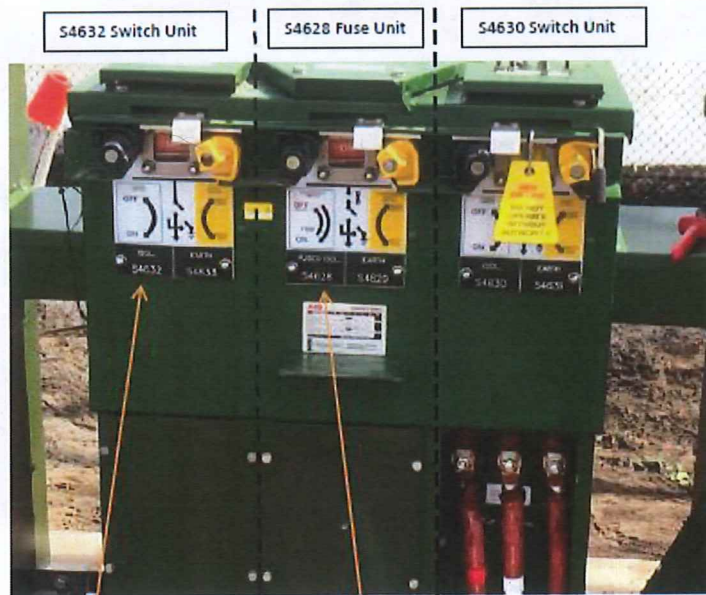
Tasman Quay ABB SDAF3 Unit

Switch S4632 was operated to phase out replacement RMU9290

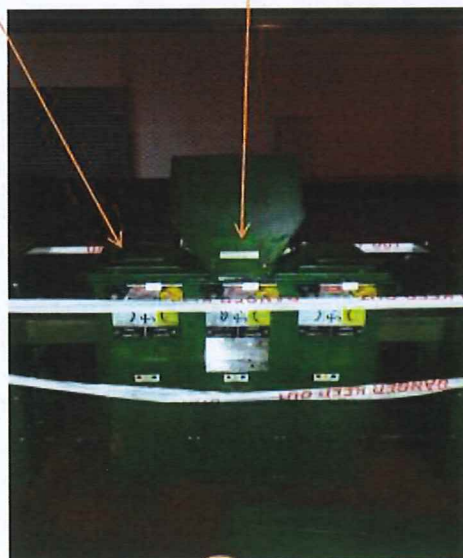
Fuse Unit S4628 failed approx. 2 secs after S4632 was operated

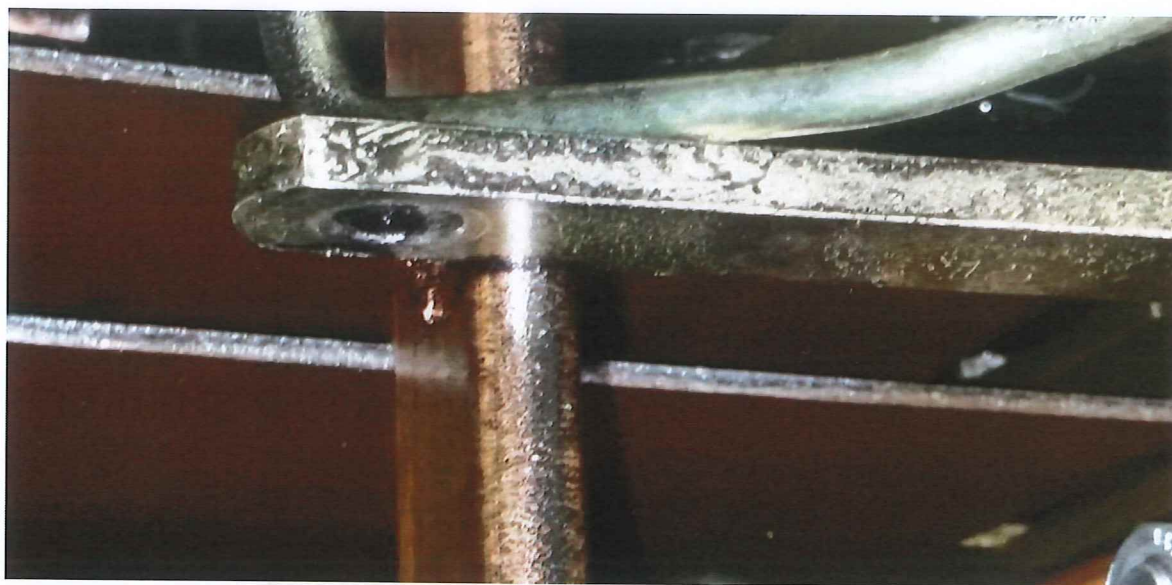
Initial investigations indicate that the malfunction occurred when one of the fuse carrier arms within the fuse switch came into contact with the yellow phase busbar when the switch was operated. The pin that holds the fuse carrier arm onto the fuse carrier appears to have become loose and fallen out.

When the equipment lid was removed the LH fuse carrier support arm was in contact with the yellow phase BUS and no pin could be found

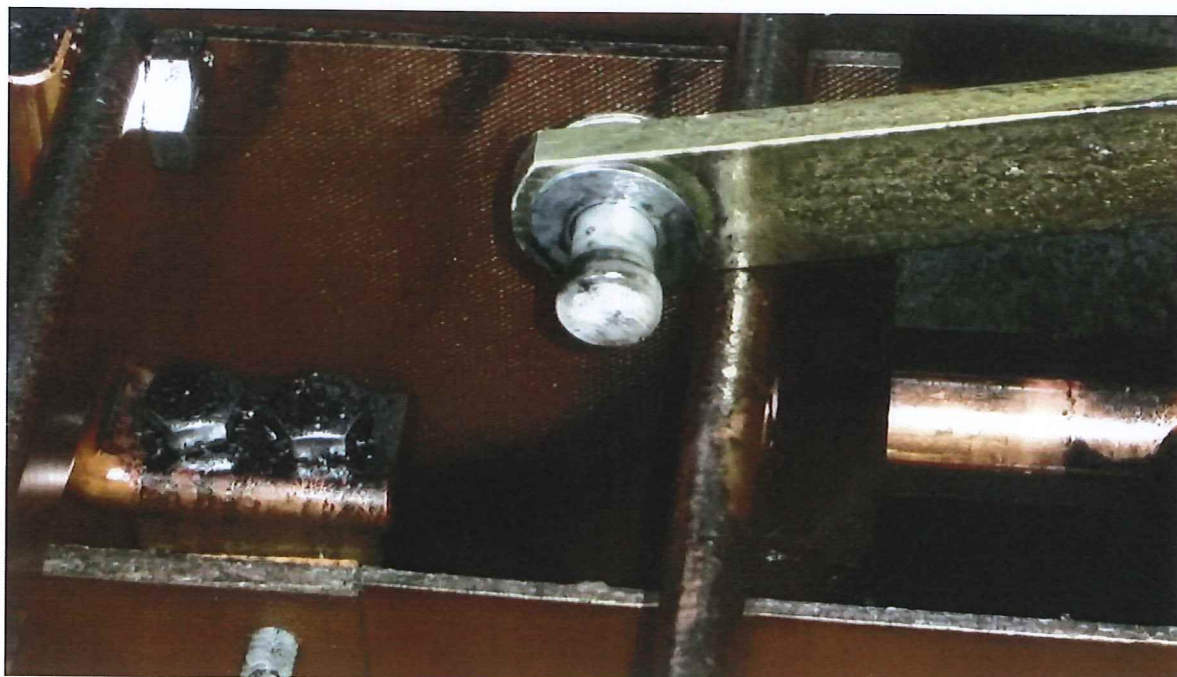
The RH fuse carrier arm still had a pin connected to the arm

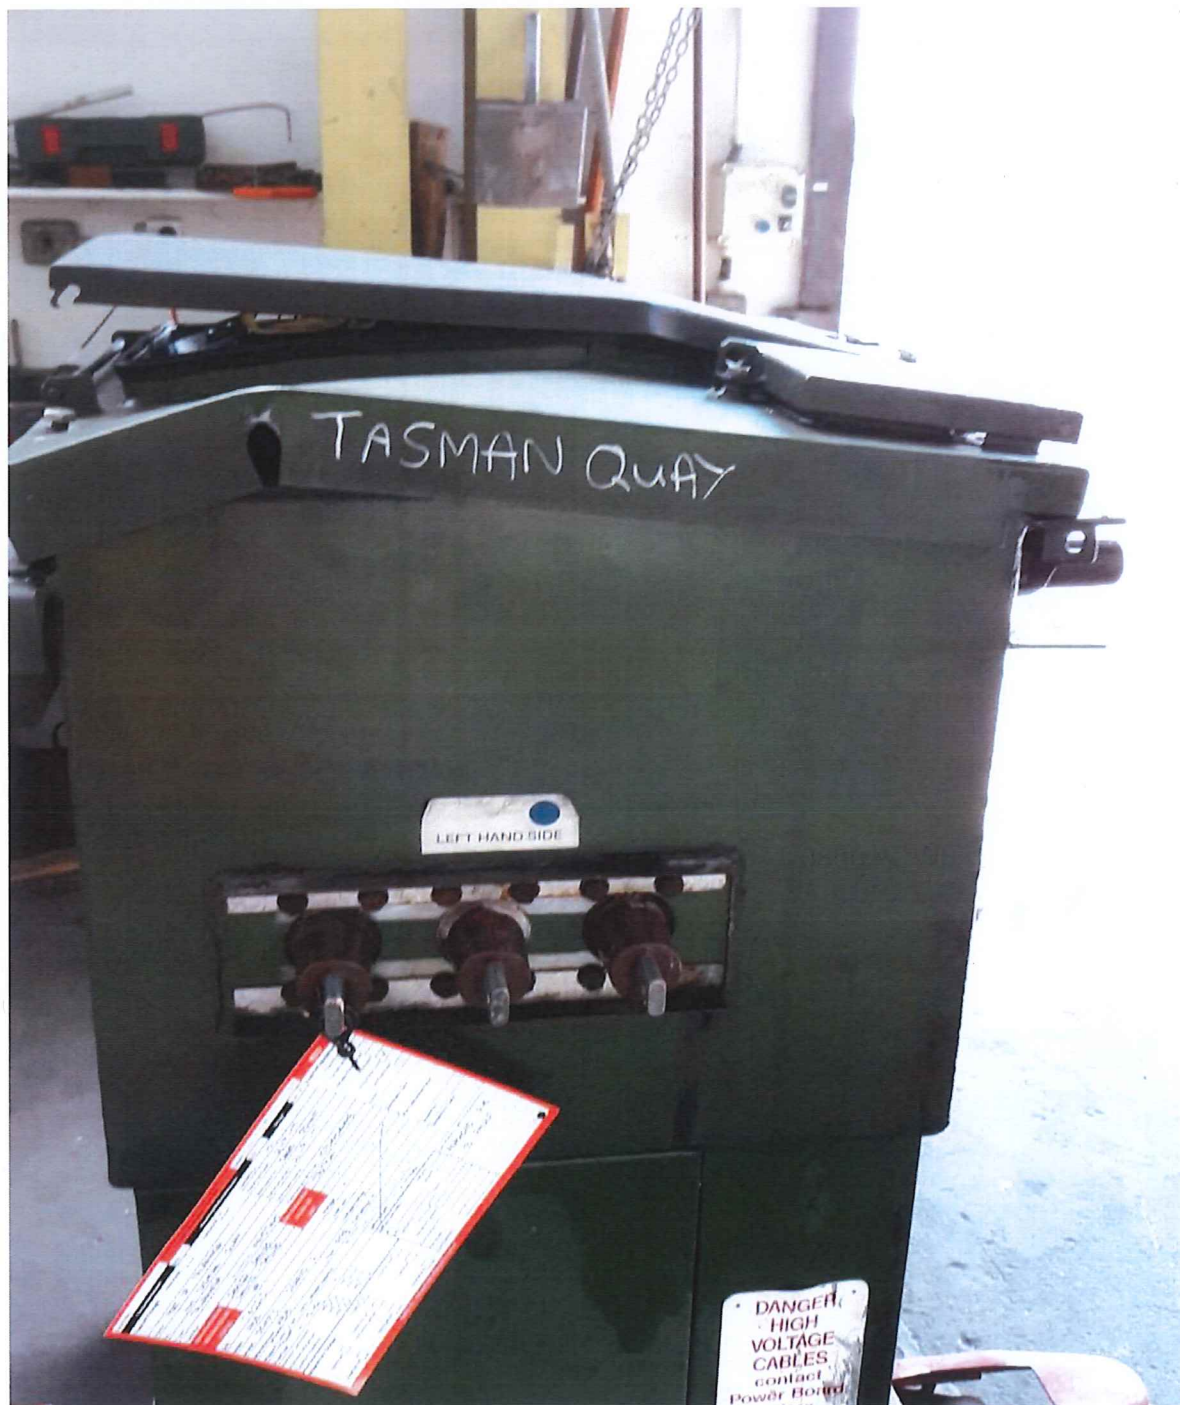
The fault caused the containment chamber to buckle and a significant quantity of oil was vented rearward (some upwardly) as a result. The location of the SDAF unit was important and in this case oil vented unobstructed to the rear of the unit.

RMU side view showing bent lid
