# Safety Alert

Orion

## SA2410 – Critical Risk - Asset Failure

### Failure of Low Voltage Panel Disconnect

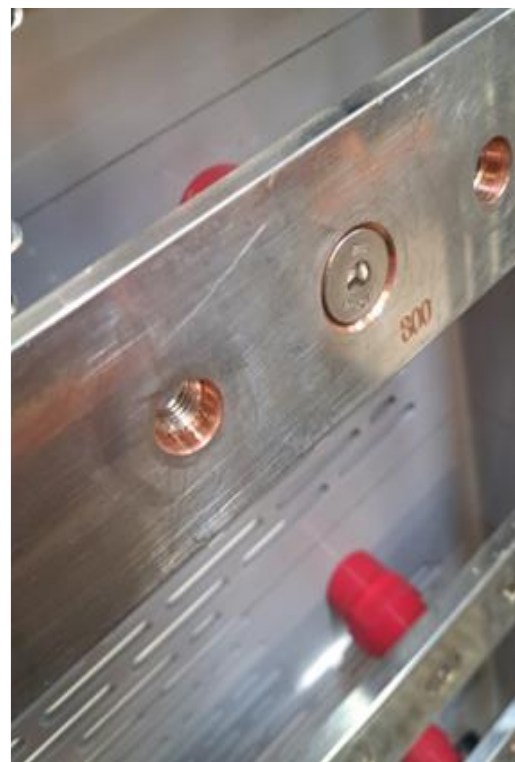
Initial investigation revealed a critical connection between an LV disconnect and an LV busbar was inadequate.

Further investigation revealed other critical connection points on the LV bus exhibiting quality issues with the riv-nut used to secure the disconnect to the bus.

These issues led to thread galling/binding, creating a high resistant connection resulting in overheating and a fire hazard.

- Pre-installation: verify that all threads are free of defects and a stainless-steel bolt can be freely moved by hand along the entire length of the thread.
- Use stainless-steel bolts of dissimilar grades to the riv-nuts for mounting the disconnectors and apply a copper coat or thread lubricant to the bolts.
- Ensure all stainless-steel bolts are torqued and comply with Orion Standard Construction drawing UF1.4.2.
- On completion, ensure that all connections are correctly tightened, with the Belville washer fully compressed.
- Report any issues to Orion Engineering or Connetics Stores.
