# Safety Alert

**INCIDENT TITLE:** Inadequate Temporary Fall Protection Barrier

**TIME AND DATE OF INCIDENT:** 13 August 2015

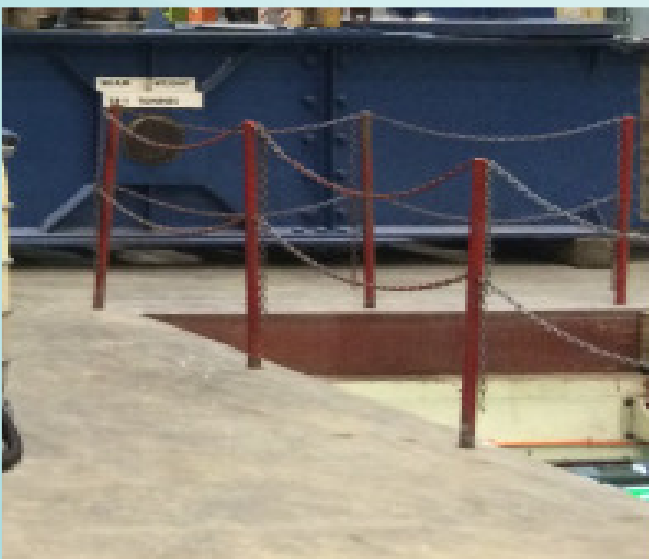
A routine Meridian GM Health and Safety Audit found that a pole and chain barrier around an open hatchway was being used in a Power Station service bay. The potential fall was approximately 12 metres. The pole and chain barrier was an inadequate control to prevent such a fall and its use represented a significant near miss event.

The investigation identified that the hazard identification and hazard management decisions taken failed to recognise both the inadequacy and non-compliant nature of the barrier put in place to protect against a fall from height. Pole and chain fencing had been used routinely at this site for many years prior to the amendments in the Building Code for safety barriers. Staff assessing the fall hazard created by the temporary removal of the hatch covers in the service bay floor decided to employ the pole and chain fence and warn other people on site of this hazard via the daily shift start safety briefings.

This hatchway is opened infrequently to provide crane access to the lower floors of the Power Station, more frequently used or permanently open hatchways have more robust barriers. There were materials on site to fabricate a suitable temporary barrier for this hatchway and temporary scaffolding had been used previously when this hatchway needed to remain open.

Generally, temporary barriers should be between 900mm and 1100mm high, include a middle horizontal rail half way between the floor and top rail, include a kick or toe board and be strong enough to withstand the side loading which could be applied. Permanent barriers protecting the public from fall hazards need to comply with the Building Code and either AS/NZS 1170 or Standards NZ Tracks and Outdoor Visitor Structures Handbook (SNZ HB 8630:2004) guidelines.

The open hatchway was closed to eliminate the fall hazard and the pole and chain barrier removed.

New barriers are being constructed for this hatchway.
