Safety Advice 03-2014 (NZ) (Jan)

Transmission

The following Safety Alert courtesy of Fitzroy Tower Painting Services and Transpower contains important hazard information on load lifting practices. Any further post-investigation advice will be posted as a supplementary advice in due course.

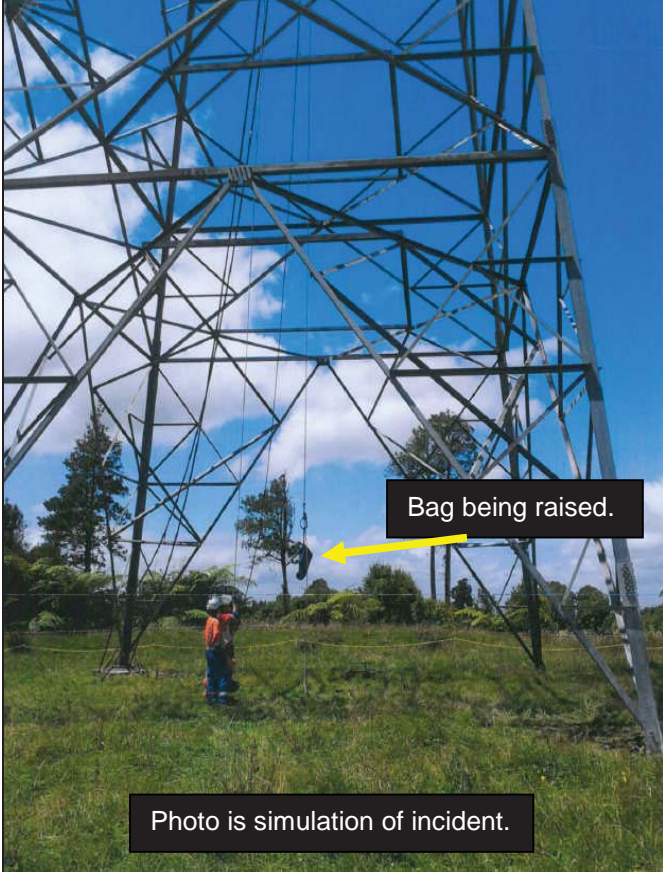
Incident title	Site	Date
Employee struck by 50kg bag of garnet.	Tower #66 Tariki	13/01/2014
Description		Attach Any Photo's here
<p>Two FTFS employees were tasked with hauling 50kg bags of garnet by rope pulley system from the ground up to the bottom arm wing of a tower, to fill a blast hopper.</p> <p>One of the employees was struck by a bag being hauled up to the blast hopper when the pull rope was unintentionally released by another co-worker.</p> <p>Work was stopped, an investigation was started and the injured employee was taken to Medicross for observation by a Doctor.</p> <p>The injured employee sustained a closed fracture in a vertebra in his neck and is on alternative duties.</p>

Cause/s of the Incident		
<ul style="list-style-type: none"> • Lack of communication between employees. • Position of employees within the drop zone. • Inexperience, fatigue and failure to identify hazards associated with the task. • Lack of monitoring (buddy check) of employees fatigue levels. • Weight of material being lifted necessitated an alternative lift method. • No intervention from fellow employees watching the hauling process.
