## *Safety Advice 05-2013 (NZ) (Jan)* *(Transmission)*

### SA- (Potential for serious harm/damage during Earthquake – BPE Project)

Date of issue: 21/01/2014

| Incident | Description |
|---|---|
| <i>Location</i> | Bunnythorpe Project – Palmerston North |

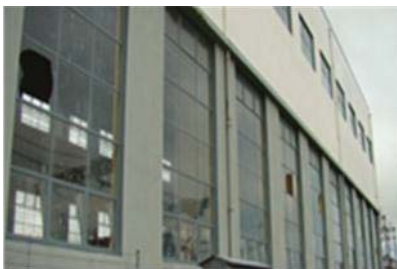
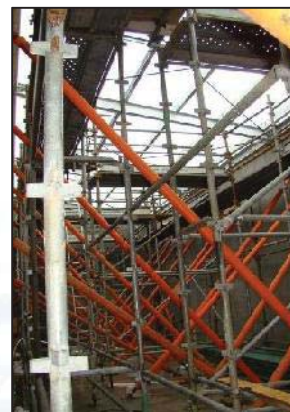
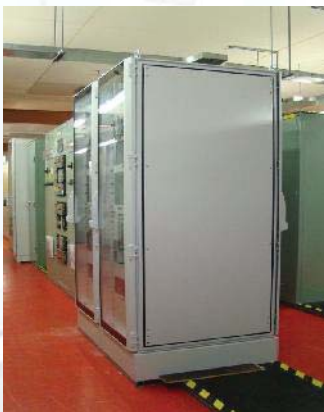
| Incident | Description |
|---|---|
| <i>Injuries/Damage sustained</i> | No injuries sustained – minor damage resulting in broken window panes in Crane room |
| <i>Event Description</i> | <p>The earthquake in the lower North Island caused some serious concerns for those staff working on the project at the time of the earthquake. There were two builders working on scaffold in the switchroom at the time and although shaken they were safe.</p> <p>That morning they had completed the majority of the new roof structural steel fixing and believe this prevented any damage to the new building which is temporarily propped and partially grouted.</p> <p>They had also just completed fixing two new Protection Panels in the existing building. Had this not been done they may have been subject to toppling. The Crane room sustained approximately 8 broken window panes.</p> <div data-bbox="507 1247 906 1514" data-label="Image"> </div> <p>Broken glass panes in crane room</p> <div data-bbox="1082 1261 1372 1671" data-label="Image"> </div> <p>Internal Scaffolding</p> <div data-bbox="517 1579 842 1989" data-label="Image"> </div> <p>Protection Panels</p> |

Lessons to be taken from this would be to ensure all heavy and unstable objects (Panels, Tilt Slabs etc.) are secured as soon as possible after erection *as was the case in this instance.*
