Safety Advice 08-2014a- (Jan) (NZ) *(Transmission)*

Tip Truck Overbalanced Final Safety Alert

E13225 – ICAR: 17900

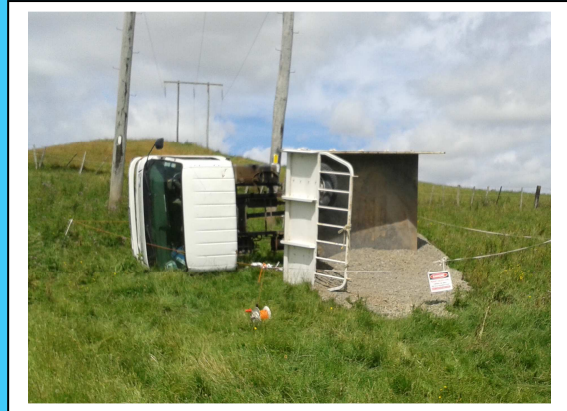
On 30 January 2014, while unloading a tipper truck full of metal, the truck overbalanced and fell onto its side. No personal injury, no property damage. Damage to the tipper truck.

Tipper truck was delivering a load of metal on the ARI-ONG A line. The truck was stationary and the tip truck operator had raised the tray to tip the metal off. As the metal began sliding off the truck, the truck overbalanced and fell onto its side.

- Tip truck operator did not identify he was tipping metal on the side of a slope and that the load could shift as the centre of gravity changed.
- No levelling device in tip truck to assist in judging if the load is level

Complacency - the tip truck operator did not position the tip truck on a level surface when unloading

- When delivering metal or other similar loads to site, ensure the tip truck is parked correct on the slope prior to operating the tray.
