Safety Advice 22-2014 (NZ) (Mar) *(Transmission)*

FIRST ALERT

Tower Painting (SNI:BRK-SFD B)Abrasive blast injury to hand

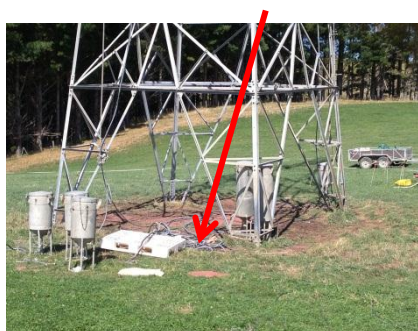
Incident location

On 21st March 2014 a five man crew was carrying out tower painting surface preparation activities (abrasive injected water jetting). An employee blasting at ground level took a break while the “groundie” took the opportunity to do some maintenance work on the guns and pumps. While dismantling a gun he was distracted by other urgent work. Meanwhile the employee finished his break, returned to his gun and began the process of reassembling the gun. This involved cleaning sand and mud off the end of the nozzle thread and during this process inadvertently pulled the trigger driving water and abrasive into his left hand at point blank range. The residual pressure in the blast hose had inadvertently not been released by either worker.
