Safety Advice 23-2013 (Aug) (NZ)

26 AUGUST 2013

VEHICLE ROLLOVER

(Opotiki & Te Kaha)

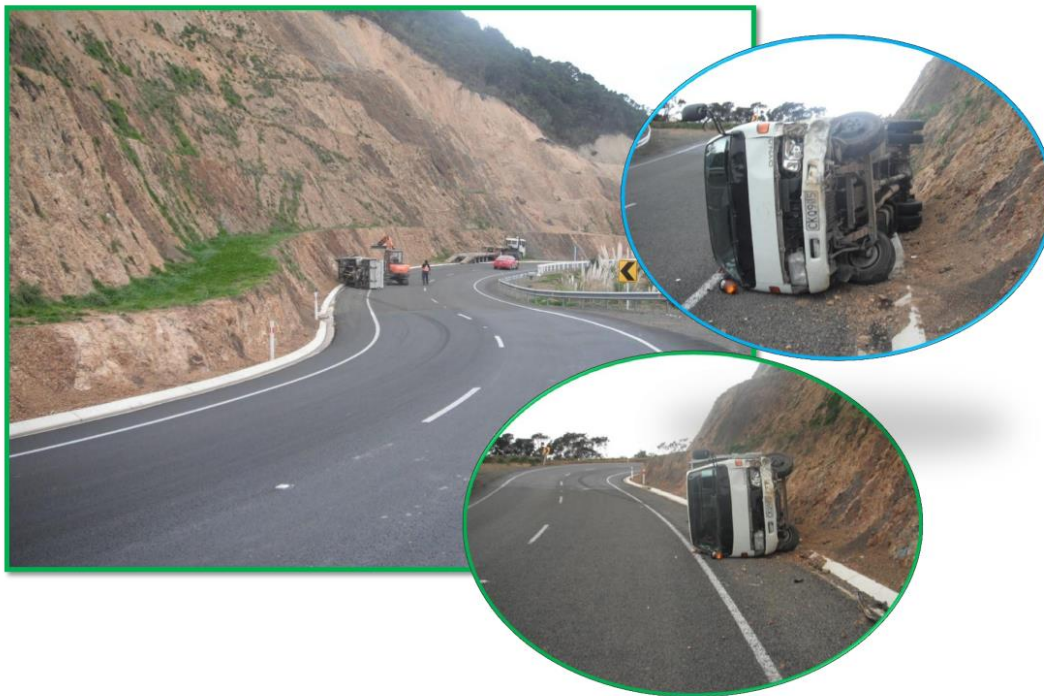
On 13 August a subcontractor employee travelling to Te Kaha lost control of his vehicle on a tight corner.

The driver overcorrected; hit a bank and the vehicle rolled.

The driver of the vehicle was shaken but unharmed and returned to work the following day.

- The apparent cause has been identified as driver unfamiliarity of the road (specifically the sharp corner).

- Police were notified and attended at the site, no action was taken against the driver
- The truck was towed from site to the subcontractors' depot
