# Incident Alert

INCORRECT LABELLING AT BASE OF POLE  
STRUCTURES  
Paraparaumu (PRM) Substation

Friday 9 May, 2014

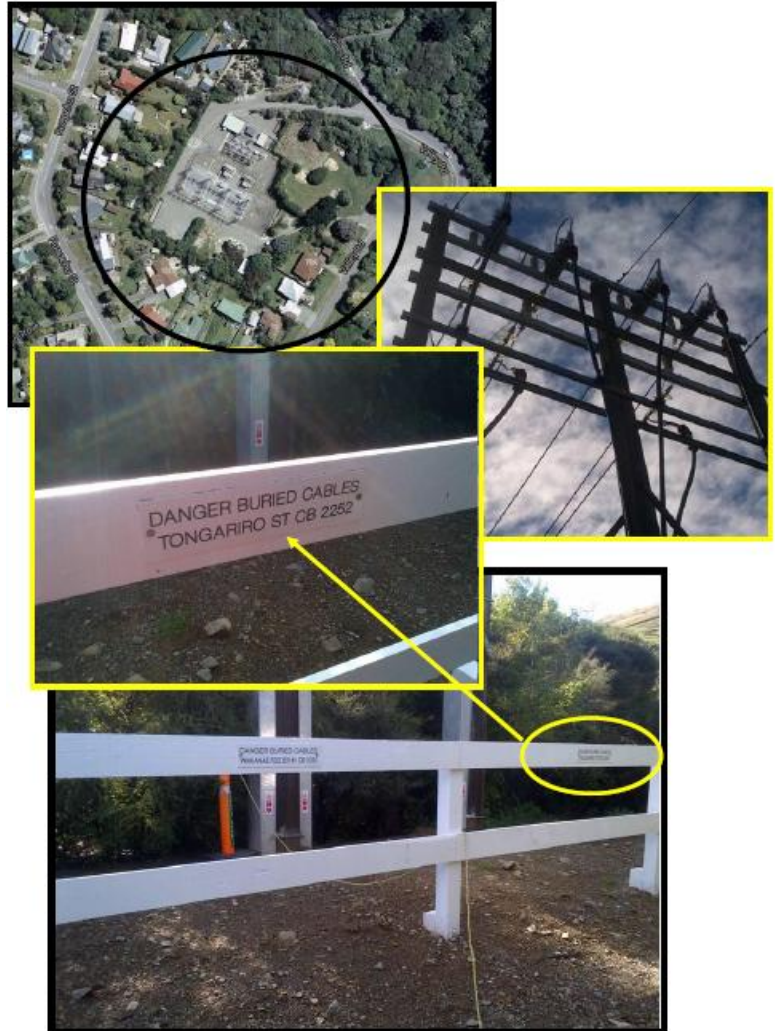
While undertaking maintenance work at the PRM Substation on 9 May, 2014 incorrect labelling was identified at the base of the pole structure which explained unexpected VDD readings.

(By incorrect it appears that the two identification labels on the structures were positioned the wrong way around).

- When testing the known 'live' circuit, they did not get an output from the VDD. Indicating circuit OOS.
- When testing the known 'isolated' circuit, they got an output from the VDD indicating the circuit was live.

It appears from early investigation that the incorrect labelling of the structures came as a result of the fence (*pictured*) being removed for project works (specifically to allow access for an Elevated Work Platform to enter site) and would later be reinstated. Part of this meant that the original labels were temporarily removed and have been reinstalled incorrectly.

- The subsequent maintenance was then cancelled, and the planned maintenance for the following week was cancelled.
- The incorrect circuit labelling was rectified.
- A joint meeting between Transpower and Transfield Services was held at site on the 12 of May, 2014 and an investigation is underway to establish root cause and learnings.
