Safety Advice 35-2013 (Oct) (NZ)

Employee received electric shock from cable screen

Electrix Event Number 12562

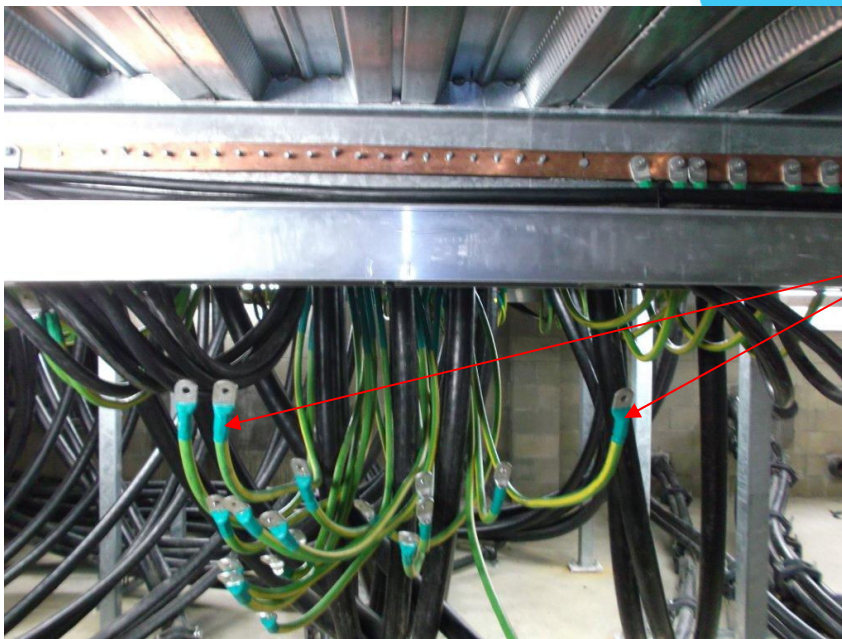
Photograph 17.10.2013
Cable basement,
Halfway Bush Substation

Earth bonding Bar

Earth Screens (disconnected)

The initial investigation has identified that earth screens were being individually disconnected from the 33kV cable earth bonding bar when the employee received the electric shock.

While it has not been established which screen had been touched or was being worked on, initial observations of the event site has identified that an earth screen from a different 33kV cable was mixed in with the screens for T2.

Until the root cause(s) have been identified, staff are reminded of the dangers associated with disconnection of cable screens and the importance of positively identifying all services prior to disconnection.
