INCIDENT ANNOUNCEMENT

Employee Serious Harm Injury – Arc Flash Burns from 415 Volt Three Phase Flash-over

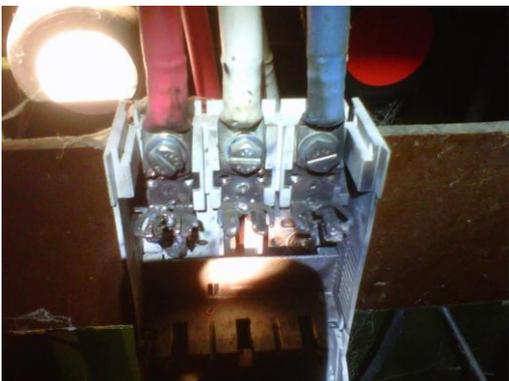
The incident occurred after the transformer at the first farm was livened and while the employee was disconnecting the portable load bank clip-leads from the line side of the transformer LV isolator (HRC fuse-switch-disconnector). The initial clip-lead connections to the line side of the transformer LV isolator were made by the employee prior to livening the transformer, and involved the removal of the shrouded terminal cover.

Photo 1 Transformer LV isolator line side terminals (Weber, 3 ϕ , 160 amp, HRC fuse-switch-disconnector).

MainPower's Network Manager Operations issued an instruction to relevant staff requiring de-energised connection and disconnection of the portable load bank via LV HRC fuses with a maximum fuse-link rating of 63 amps.

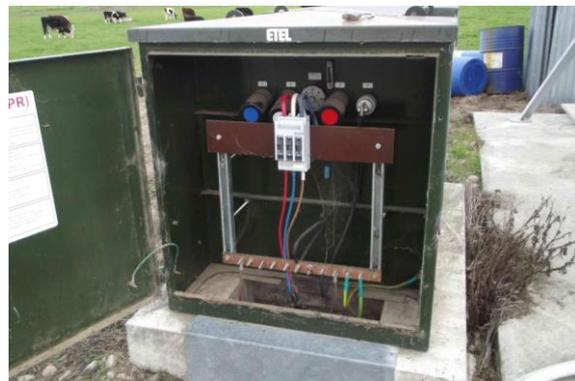
Photo 2 Transformer site (3 ϕ , 100 kVA, 22 kV/415/240 V). New transformer LV isolator installed.

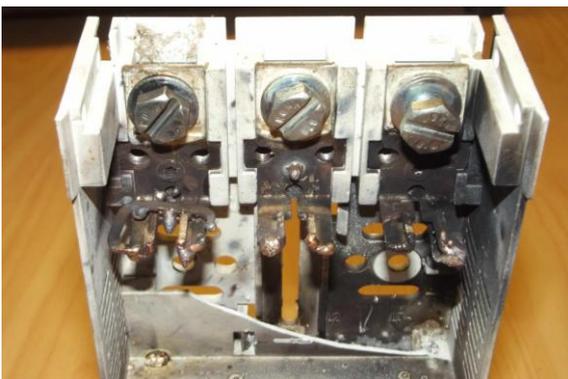
Photo 3 Transformer LV isolator line side terminals

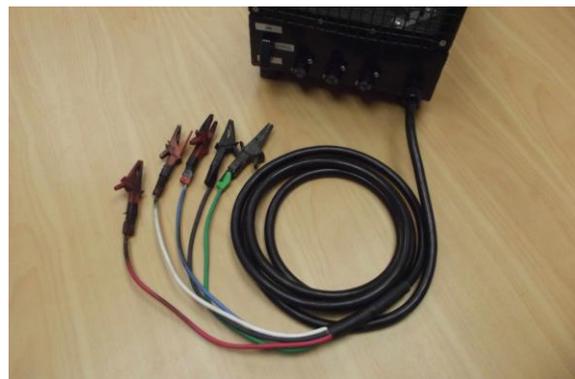
Photo 4 Portable load bank clip leads (3 ϕ + N & E)

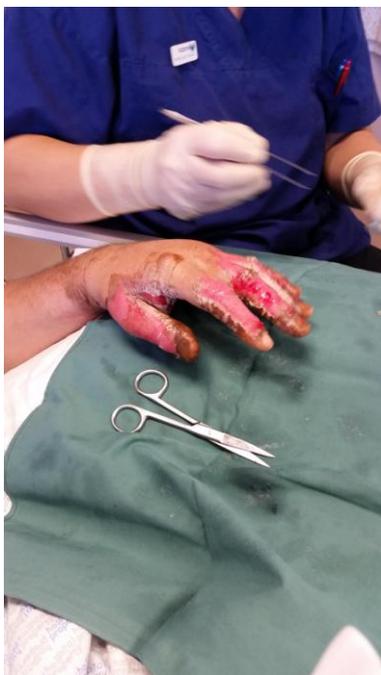
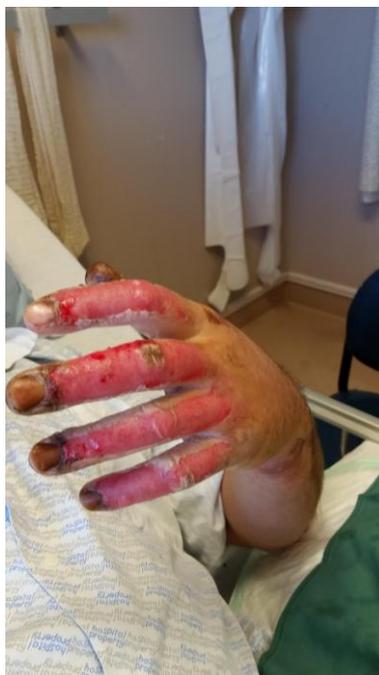
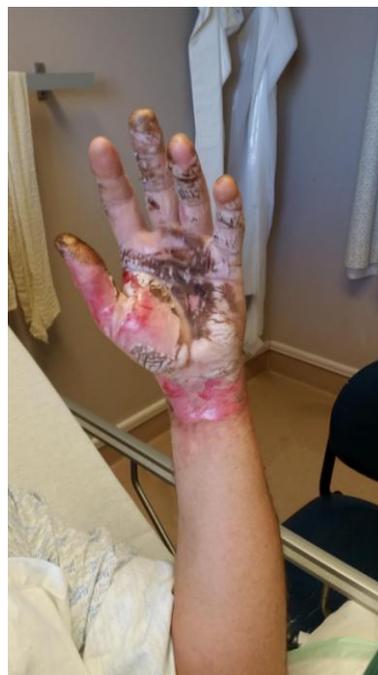
The employee sustained serious harm injuries. Specifically, full thickness and partial thickness burns to both hands, with most of the burns on his left hand.

The following photos were taken on the fourth day and are associated with the removal of dead skin from the employee's left hand.
