Safety Advice 39-2013 (Oct) (NZ)

safety alert

MAN – TWI A OPGW Running Block

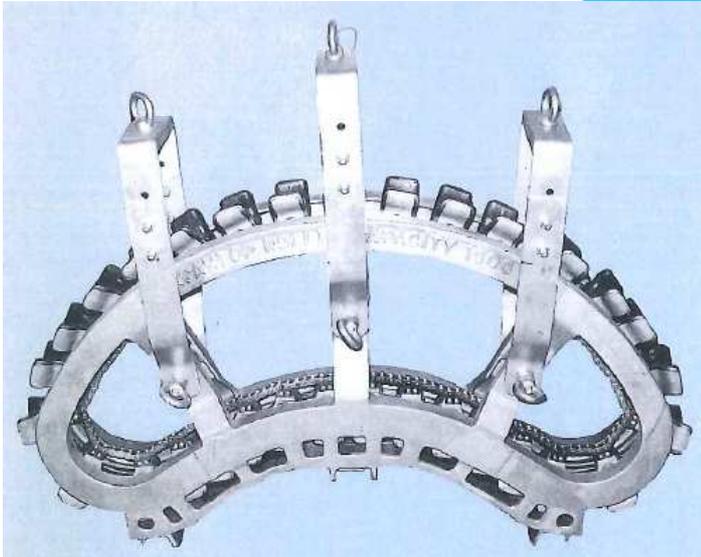
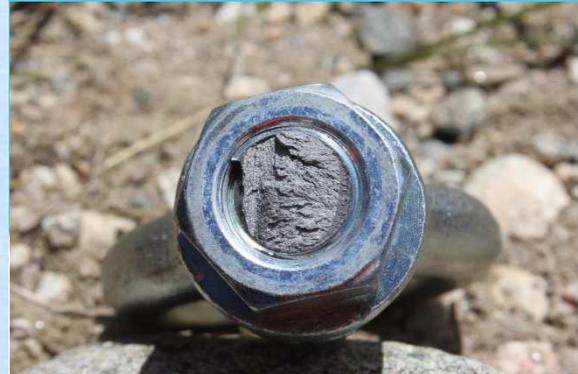
A new NGK caterpillar running block failed resulting in the block twisting and the OPGW falling out of the rollers. When the OPGW fell out of the rollers it grazed across a linesman face and shoulder before forcing and trapping his arm against the earthpeak steel.

An attachment eye on a NGK caterpillar running block failed.

Checks and inspections on NGK running blocks should to be thorough to determine if there are any sign of weakness/distress especially around the attachment eyes until a full investigation has been completed.
