30 May 2014

## Live Unterminated Cables in Building

Substandard cabling practices

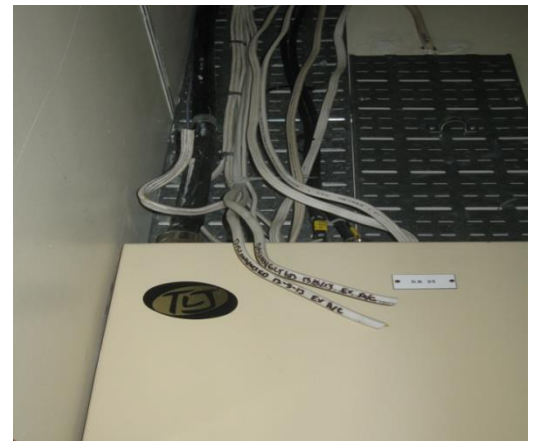
A recent incident when a technician received a shock when he brushed against a cable with live unterminated ends in a cable tray has highlighted substandard cabling practices in that area.

- earth conductors not bonded to earth – leading to unearthed cable trays
- unterminated ends of cables exposed – potential shock hazard
- redundant cables left in place
- unlabelled coils of cables in/near switchboards.

- ensuring that all cable ends are terminated
  - capping all exposed ends in an approved manner to prevent inadvertent contact
  - removing redundant cabling; if this is not possible, each cable conductor end must be shorted out and earthed to prevent inadvertent livening
  - clear marking of cabling
- substandard cabling identified should be tested, isolated if appropriate, tagged, and immediately notified to Transpower
  - securing the affected area to prevent further entry until completing rectification of the substandard cabling.
