# Incident Alert

While floating an earth wire the comealong came off the earth wire tail.

Alert Number: NZ-11062014-ES

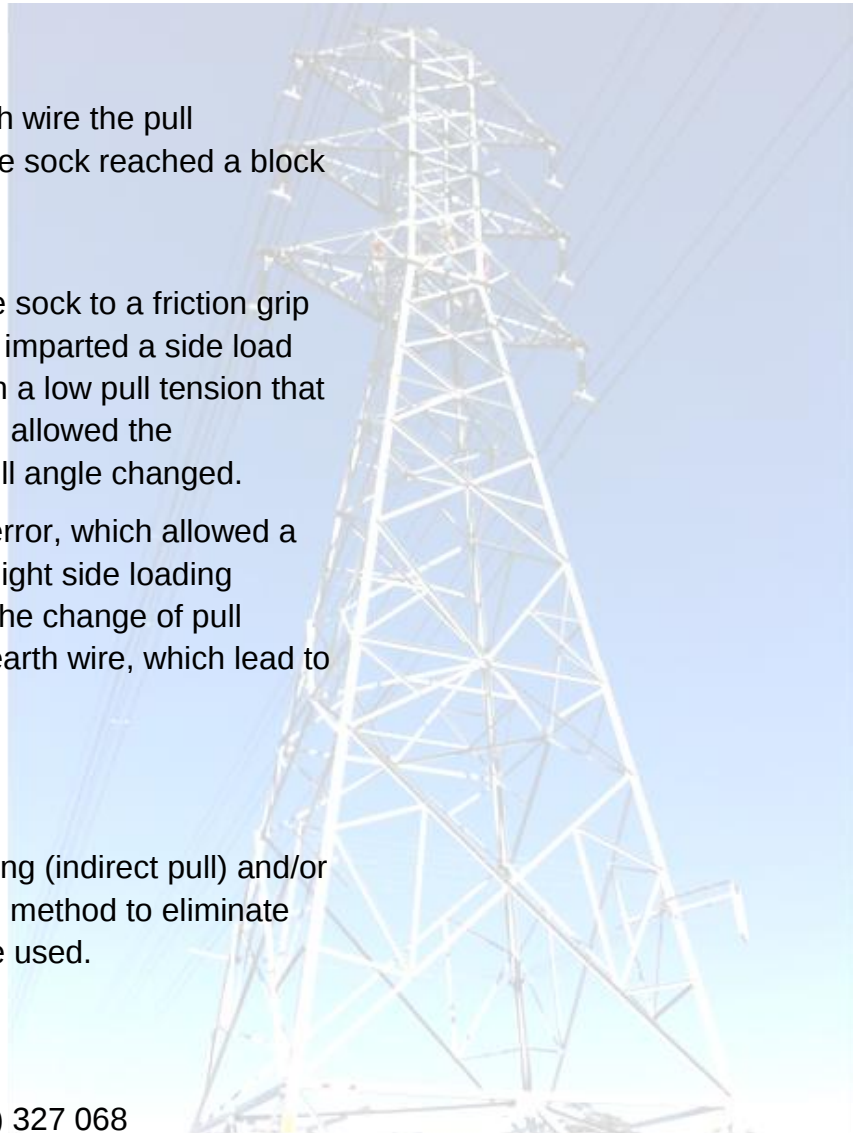
Changing the attachment point from the sock to a friction grip meant a change in pull direction, which imparted a side load on the comealong. This, combined with a low pull tension that did not provide sufficient gripping force, allowed the comealong to pull off the wire as the pull angle changed.

The cause of the failure was a rigging error, which allowed a combination of the low pull tension, a slight side loading (indirect pull) of the comealong due to the change of pull angle, coupled with the twisting of the earth wire, which lead to the failure of the comealong.

Where there is a potential for side loading (indirect pull) and/or low pull tensions a review of the rigging method to eliminate these, or a bolted comealong should be used.
