safety alert

Finger Injury

Final Safety Alert to initial one released on 17 May 2014

Electrix Event Number
14051

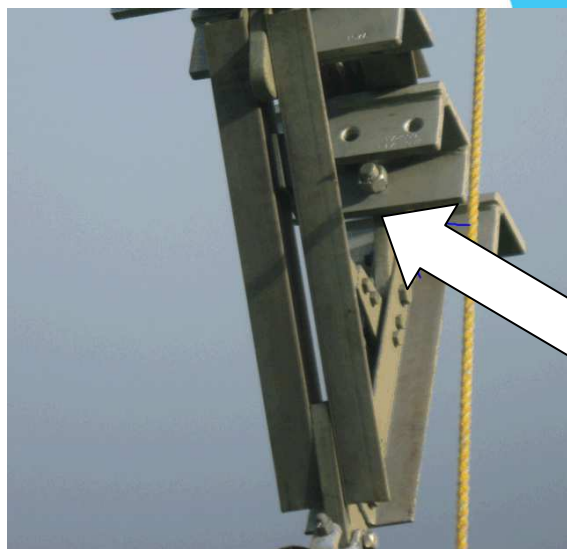
The Line Mechanic caught his finger between two pieces of metal as he tried to locate the hanger bracket into its final position.

The 64kg weight of the new hanger bracket was being supported by a chain hoist. Due to the clearances between the hanger bracket and the attachment point being minimal the line mechanic tried various methods to get the hanger bracket to fit, including loosening all of the bolts for the attachment point but still needed to physically force the hanger bracket into the attachment point.

- The work position decided on by the line mechanic complicated the task of installing the hanger bracket into the attachment point. He did not identify the pinch point hazard in his initial hazard identification

Arrow indicates where finger got caught between hanger bracket and attachment point.

- Thorough prestart planning and hazard identification on site must be completed prior to carrying out assigned work including assessment of hidden hazards like pinch points. Appropriate control measures must then be used to prevent harm. The hierarchy of control is **Eliminate, Isolate, Minimise**.
