## Event Notice - Equipment Failure

11kV Oil Circuit Breaker failure during fault

September 2013 ID 13015

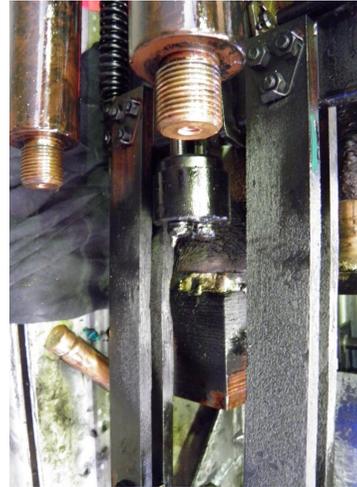
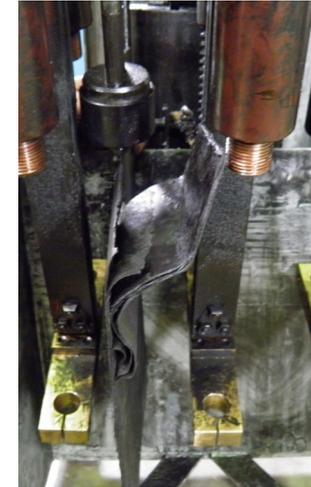
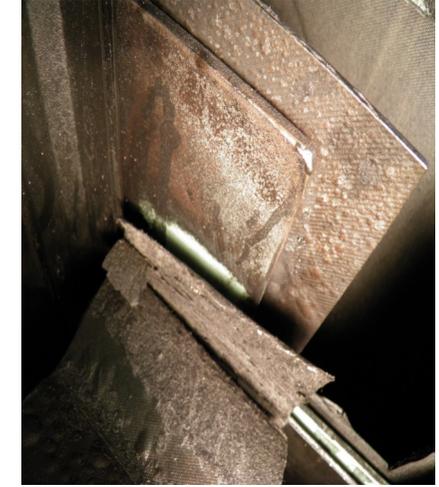
The oil circuit breaker failed catastrophically, causing extensive heat damage to the surrounding area and causing the safety glass to blow out of the substation.

An internal three phase fault occurred within the circuit breaker during or shortly following the clearing of a fault. The barrier board between phases was found to be damaged which led to this internal arc being created. Because of the nature of the damage, it is possible that there are other Brush CB units that exhibit similar problems. To date the Brush circuit breakers have had no recorded failures of this nature within Orion's network.

It is believed that the insulating barrier board was damaged when the circuit breaker was reassembled after maintenance.

Following any internal work being carried out it is important that the barrier board is correctly replaced in the tank and that it is not damaged when reassembling the circuit breaker tank.

Signage has been installed at Bishopdale, Montreal and Spreydon Zone Substation whilst further investigations and actions are undertaken. The signage indicates the precautions to be taken when working in these substations including an increased level of PPE required.

Operating procedures have been altered to delay the reclosing of these circuit breakers immediately after operation.

Staff and contractors will be asked to vacate the switchroom when any switching is carried out, which will be completed remotely where possible.

A review of maintenance carried out at Bishopdale will be completed and remedial actions required will be completed
