Safety Advice 7-2012 (NZ) (Feb) *(Transmission)*

Incident Alert

PULLING ROPE FAILURE
(BPE HAY A Replacing Conductor Span 163 164)

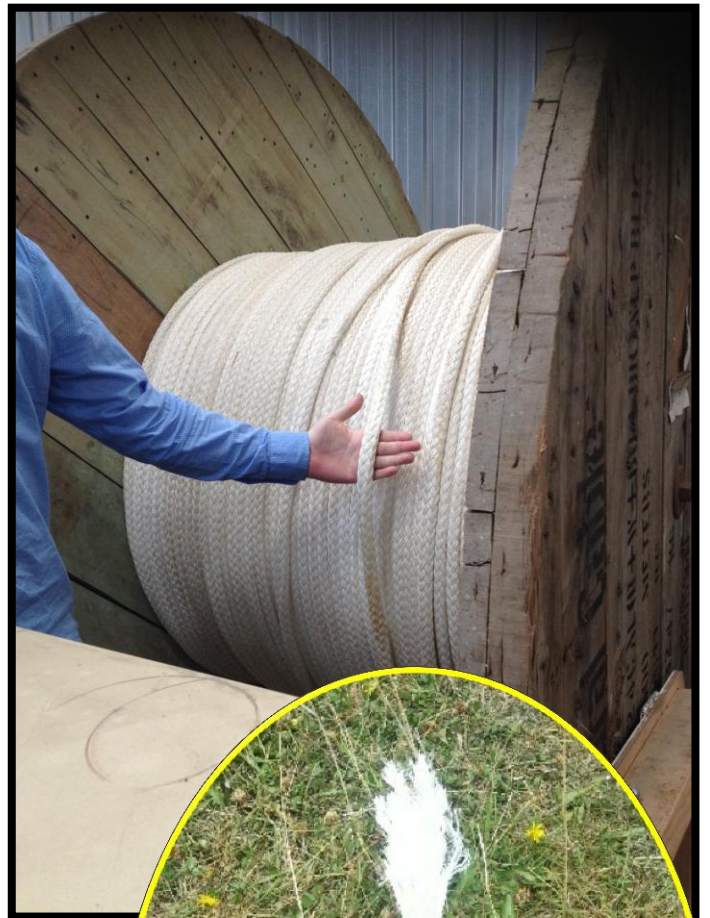
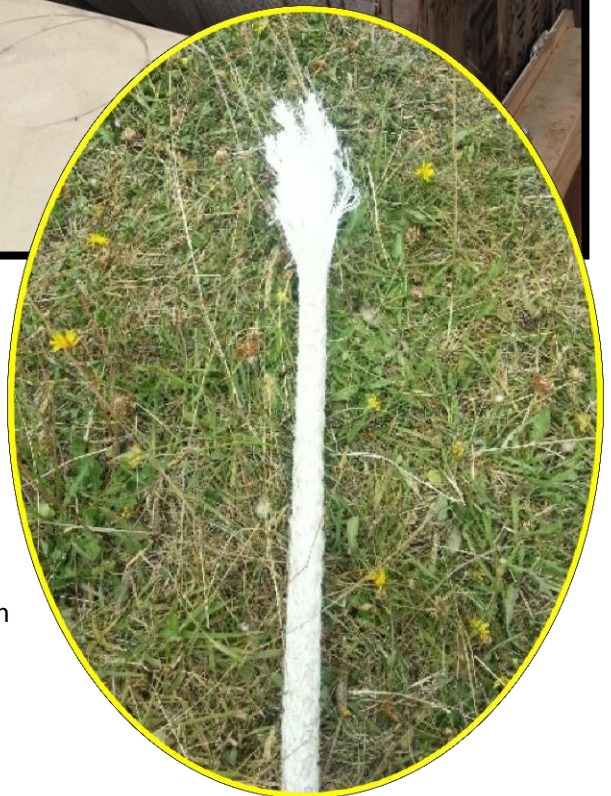
During conductor replacement works on the BPE-HAY-A line the rope (a 12 ply polyester rope 10.7 tonne safe working load) which was being used for the tension stringing operation (to replace corroded conductor between two towers) failed under load.

Full tension on the conductor had been released at the tensioner end and the safety was on the conductor at the puller end. As the tension was taken up on the puller to release the safety, the pulling rope broke and released back onto the safety stop/grip.

The conductor was just above the ground at this time and well below full tension (estimated load at the time the rope failed was 1.5 -2 tonne). No one was injured and no damage to equipment/property occurred. The outer layer of rope on the drum (approximately 60m) was discarded off the drum as per standard practice and the rope which was to be utilized as part of the pulling operation undertook a full visual inspection prior to use.

- All rope similar pulling rope of the same age and construction has been quarantined at the Upper Hutt Depot pending an inspection.
- A new rope was purchased for the pulling operation.
- The Crew was re-briefed before work restarted.
- All staff will be reminded (at the toolbox on 10/02/2014) of the importance of visual rope inspections prior to use.
