Reference no.: EXP-11-248 INC-1027490 - SPM - Secondary transformer failed disruptively.

Date: 09/04/2019

IN-SERVICE FAILURE OF 500kVA ORMAZABAL CABLE-CONNECTED DIST.TRANSFORMER NETWORKS

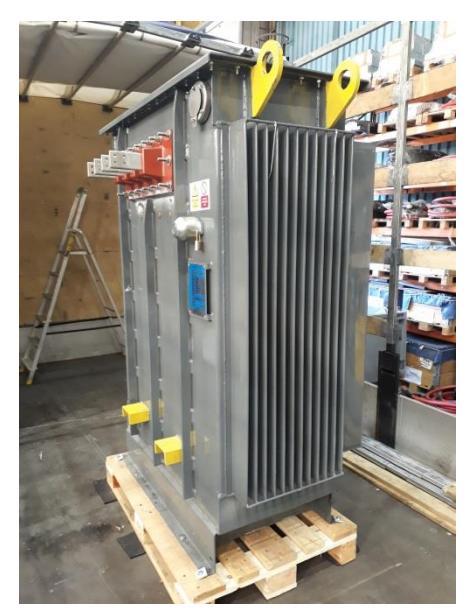
- The transformer did not disruptively fail as the tank integrity was not compromised during the fault event (Fig.1).
- No evidence was found that a flashover in air occurred due to exposed HV conductor or terminals caused by low oil level.
- There was an HV winding fault caused either by a manufacturing defect or particle contamination during manufacturing; or,
- A Tap Changer fault caused either by a manufacturing defect or a high resistance in the tapping leads connection.

Fig.1 Failed Wandsworth Way transformer as arrived to Ormazabal UK facilities

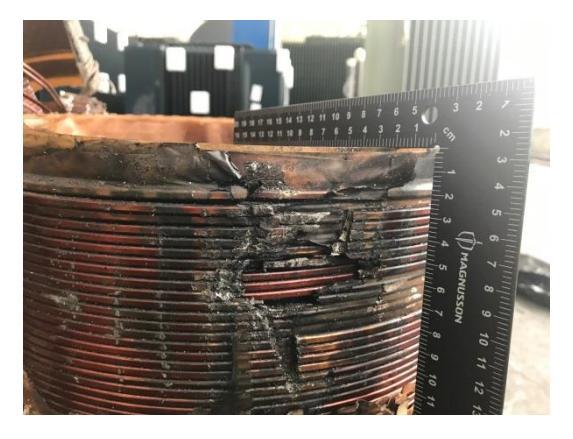
Fig.2 Evidence of damage to HV winding

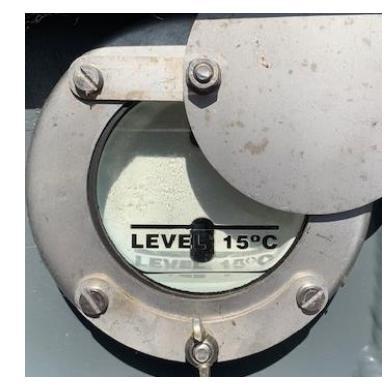
Fig.3 Oil gauge showing level below level gauge cannot be trusted

- It has been found during the investigation that the oil level indicator provided is a defective design which traps a small amount of oil at the bottom of the gauge even if the oil level is below that point (Fig. 3). If oil is found at the minimum level, indication shall not be trusted and oil level checked by other means (e.g. removing lid).
- Where oil level is found to be low but no oil leaks are visible, the HV cable box cover shall be removed for inspection of HV bushings as this area has been a source of leaks in recently delivered transformers.
