UPDATE. IN-SERVICE FAILURE OF 500kVA ORMAZABAL CABLE-CONNECTED DIST.TRANSFORMER

[EXP-11-248](#) highlighted the failure of a 500kVA Ormazabal cable-connected distribution transformer, and the subsequent investigation into all ground-mounted distribution transformers manufactured by Ormazabal.

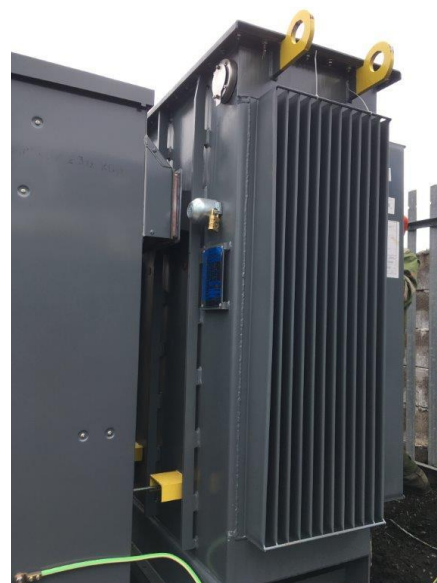
Further to the ongoing investigation there has been another failure of a 500kVA GM cable connect unit (Motehill). This unit had been in service for two days.

Given the early failure of the latest unit an investigation will be carried out to determine the cause. Transformers which have been installed but not yet energised or in stores shall not be energised until further notice.

Failed Motehill 500kVA Transformer

- **Transformers which have been installed but not yet energised or in stores shall not be energised until further notice.**
