# Switching Review Check Sheet

| Score | 12 / 26 (46.15%) | Flagged items | 0 | Actions | 0 |
|---|---|---|---|---|--|
| Location | | | | | Findlay Street, Hamilton East,<br>Hamilton 3216, New Zealand<br>(-37.7970607, 175.3034323) |

What type of work is being observed?

- Isolation / Relivening

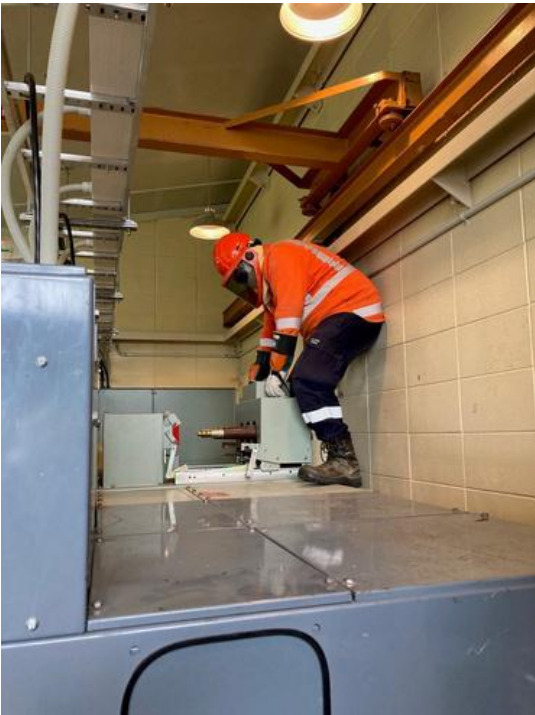
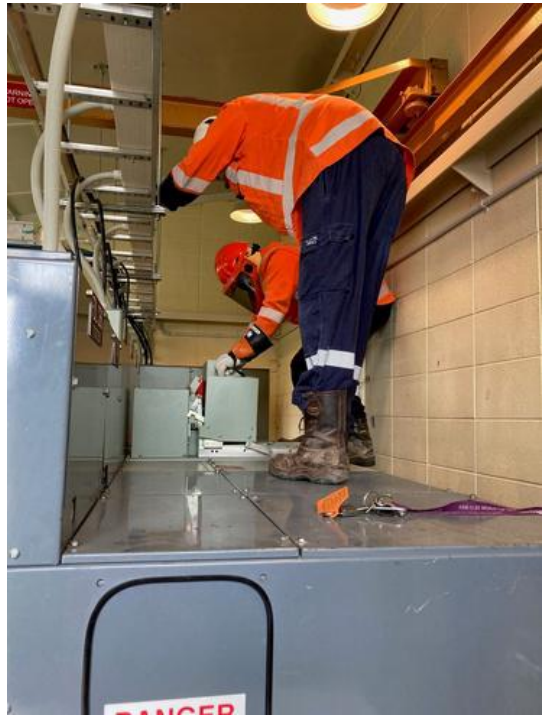
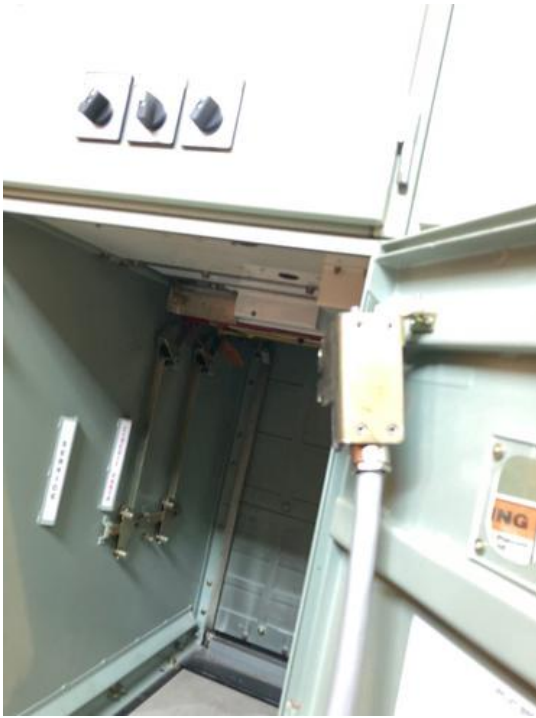
Removal of the VT requires climbing up onto switchgear as there is no rear access. As this was a total bus outage, there is no need to remove the VT from service. A more ergonomic solution would be remove the VT fuses to prevent a potential back feed and locate the fuses on the front face of the switchgear panel. This will remove the need to clamber up onto the switchgear
