## Incorrect Use of Emergency Showers

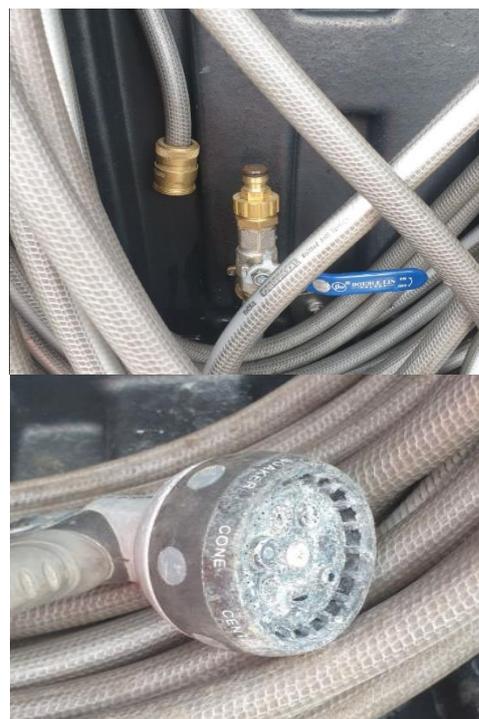
While undertaking site inspections it was found that a number of emergency showers were missing their anti-tamper devices (plastic ties). On closer inspection a combination of the following issues were also observed:

- The shower nozzle and hose contained foreign (dry dirt) residue or was damaged.
- The multi-mode shower nozzle was in “Jet” mode and not “Shower” mode as required.
- The hose was not attached to the water supply.
- The Spray nozzle had been removed from hose and located elsewhere on site.

- Shower nozzles were cleaned and repaired.
- The hoses were properly coiled and stored to ensure there were no kinks to stop water flow.
- Shower nozzles were turned to the correct “Shower” mode. When treating burns “Jet” mode could cause permanent damage to the user.
- Shower cabinets were closed and fitted with new anti-tamper device.

- Investigate installing an alarm system in conjunction with anti-tamper device
- Review stations SMP's to ensure these are monitored more frequently
- Review usage of multi-mode nozzle and replace if needed
- Ensure near miss incidents are entered into Maximo for each time found at a site.
