LVAC Sockets in Transpower Substations

Photographs – Examples of LVAC Sockets in Poor Condition

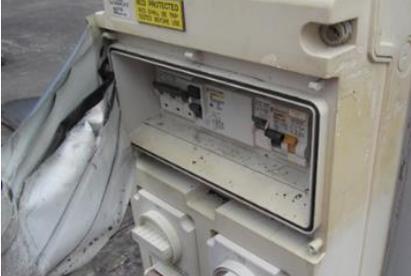
Description	Photograph
<p>Pin Corrosion</p>

<p>Visible "tide mark" – severe damage</p>
<p>Missing MCB Cover</p>

- Please remain vigilant of sockets which may be in poor condition. If a socket is noticed to be in poor condition at any time, it should be labelled 'Do Not Use'. The next implementation of the updated SMP will determine if that socket can be repaired or if it should be decommissioned.

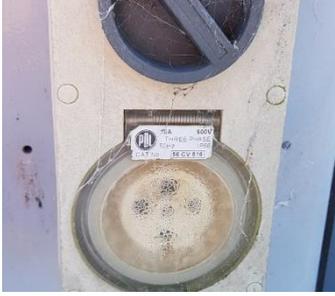
<p>Missing cover may compromise protection (e.g. moisture ingress to RCDs)</p>

<p>Moisture Inside Socket Cover</p>

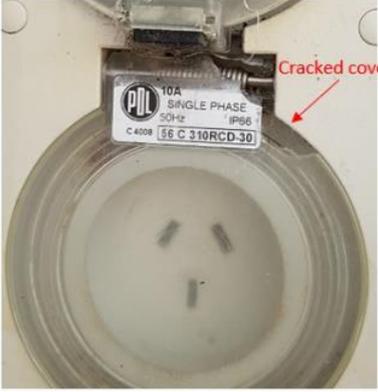
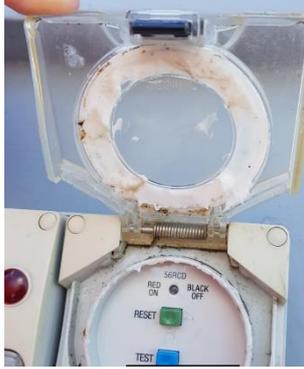
<p>Condensation</p>	<p>Moisture Ingress</p>	<p>Water Ingress</p>
<p>Damaged Socket Cover</p>

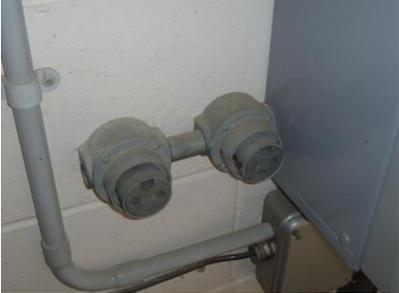
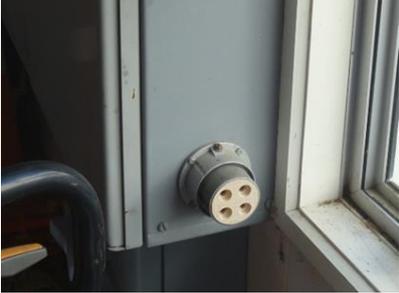
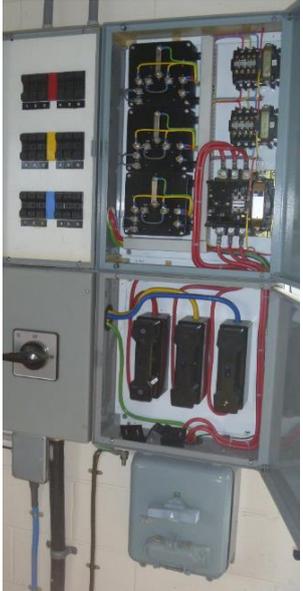
<p>Cracked Cover</p>	<p>Poor Sealant Condition (e.g. sticky gaskets)</p>	
<p>Old Sockets and Equipment</p>

<p>Old Scraping Earth Sockets</p>	<p>Old Earth Monitor / Filter Outlet</p>
