# Safety Bulletin

## Stay safe in substations and compounds and avoid a slip, trip or fall' – Cable trench and drain covers

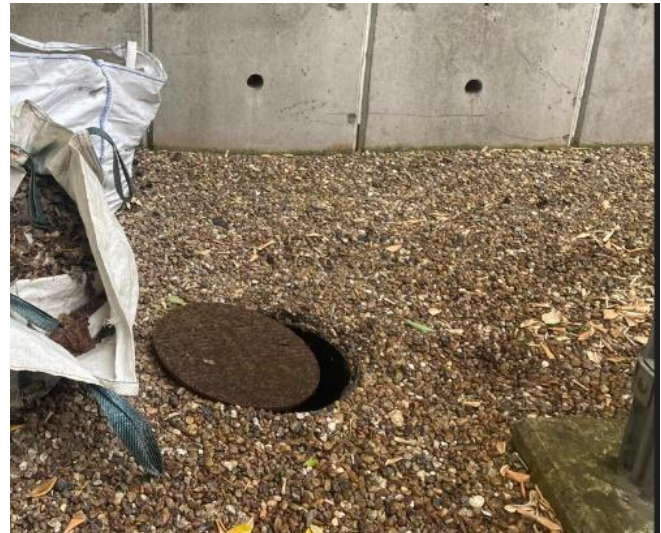
In June one of our colleagues was walking round the perimeter fence of an outdoor compound at a primary substation when the drain cover they stood on gave way. The fall resulted in cuts to the lower leg but thankfully no serious injuries.

The cover looked to be secure but dislodged as it was stood on due to the plastic frame being broken causing the cover to be unsecure.

Pictures of the misaligned cover after the fall and the broken cover frame can be seen on the enclosed pictures.

- Risk assess routes within the site to ensure access and egress avoids stepping on covers where possible.
- Ensure you are wearing the correct PPE and footwear.
- Keep you and your colleagues safe, if you remove covers as part of your work ensure they are properly refitted once the work is complete.
- We continue to rectify any issues reported with covers. We are particularly interested in identifying outdoor sites fitted with plywood trench covers. If plywood covers, located in these sites are encountered, they should be reported using the EcoOnline system. All missing or misaligned covers that present a trip or falling hazard, covers in poor condition or not secure for any reason should also be reported in the same manner.

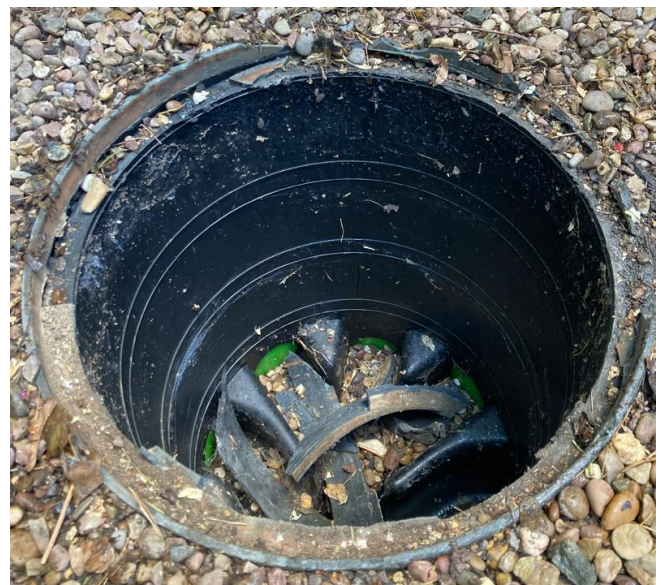
The covers are predominantly made of reinforced concrete, metal, standard or marine grade plywood, or GRP construction. Structural deterioration of the covers is often on the underside and as such a visible inspection is not an adequate assessment as to the condition of the covers.
