# SHE ALERT

## Fire

Date of incident	3 <sup>RD</sup> May 2024		Directorate	Large Capital Delivery	
Region	SHEPD Delivery	Location	Shetland	Classification	PTBW

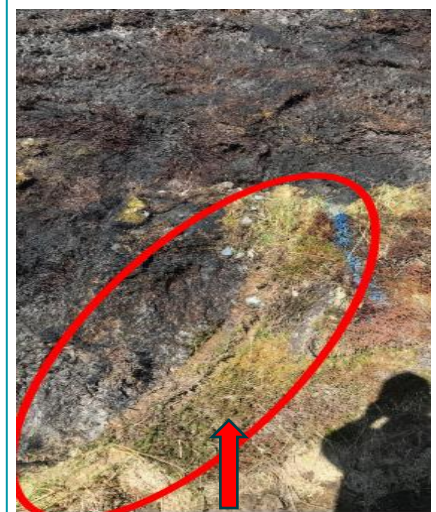
Area where cable was laid

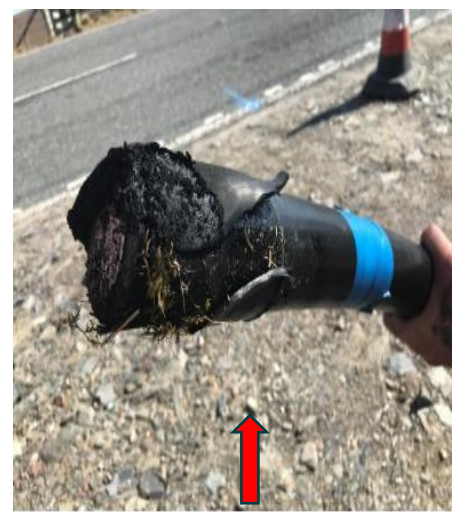
A short time after testing the “Blue” phase cable (there are 3 cables forming the circuit and are referenced “Red”, “Yellow” and “Blue”), a passing motorist stopped and advised the contract partner team that there was a fire at the end of the cables (the Remote End).

Fire damage to Blue Cable

- React and adapt to ever changing environmental conditions.
- Follow prepared Risk Assessment and Method Statements
- Carry out an effective risk assessment and as works continue stop and carry out 20 second scans
- Ensure when carrying out testing activities that cable is prepared, ends raised and each end is appropriately supervised.
- With recent dry weather, fire warnings have been issued across our operating areas, so consider the risk of fire from our activities and have proportionate mitigation in place
- Everyone is empowered to use our license “ If it's not safe, we don't do it”

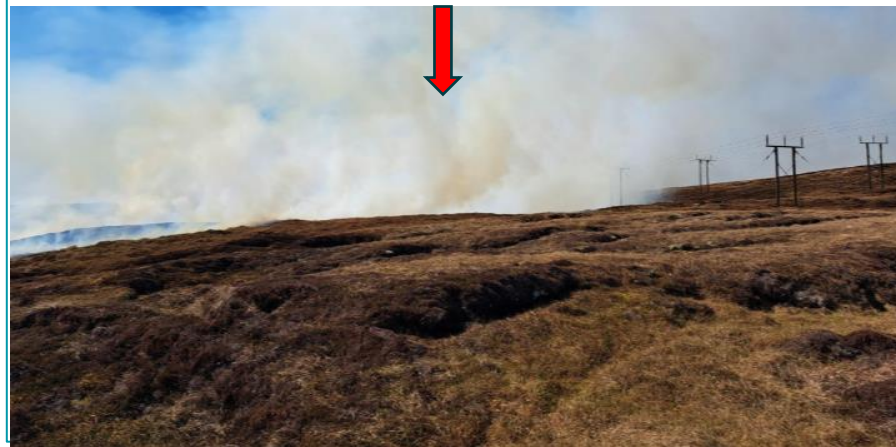
Our contract partners jointing and testing team were carrying out 5kV sheath tests on a newly installed 33kV circuit. Weather conditions in area has seen very little to no rain and this had caused the heathlands to become very dry.

Heathland Fire
