Safety Action Notification

Corrosion Under Pipe Clip

Location/Site: NEWTON NOYES BLOCK VALVE

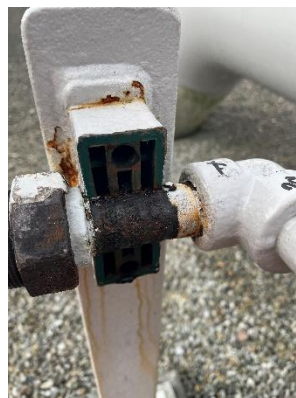
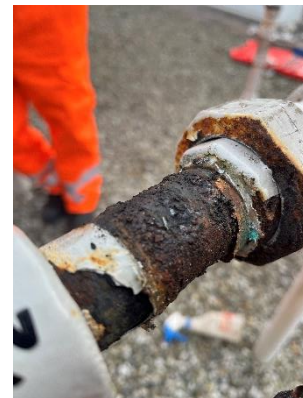
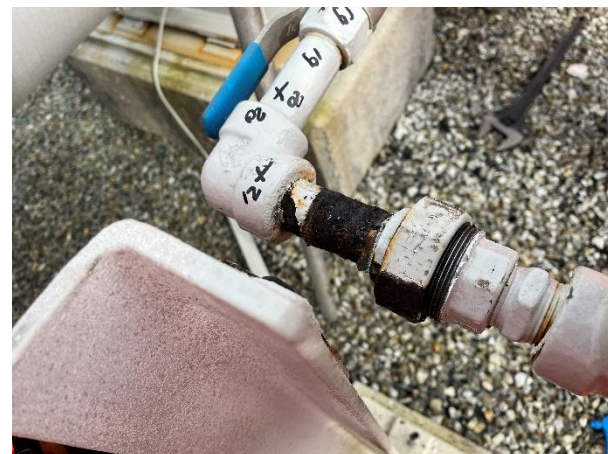
Upon removing a pipe clip in order to access a small section of pipework undergoing repair, there was some severe corrosion that was hidden.

This had the potential to eventually result in a gas leak if left untreated.

It was impossible to see this corrosion without taking the whole pipe-clip apart.

From the outside the pipework seemed to be in perfect condition as it had recently undergone new coating works

Left untouched then this could have remained undetected until it began to leak.

Care to be taken when disturbing pipe clips and supports in case corrosion is present underneath.

Any corrosion defects found to be raised with line manager.

Management of corrosion and paint defects to be carried out in line with T/SP/CM/4.

CM/4 defects to be raised in accordance with the specification requirements.
