SHE ALERT

Crushed Finger

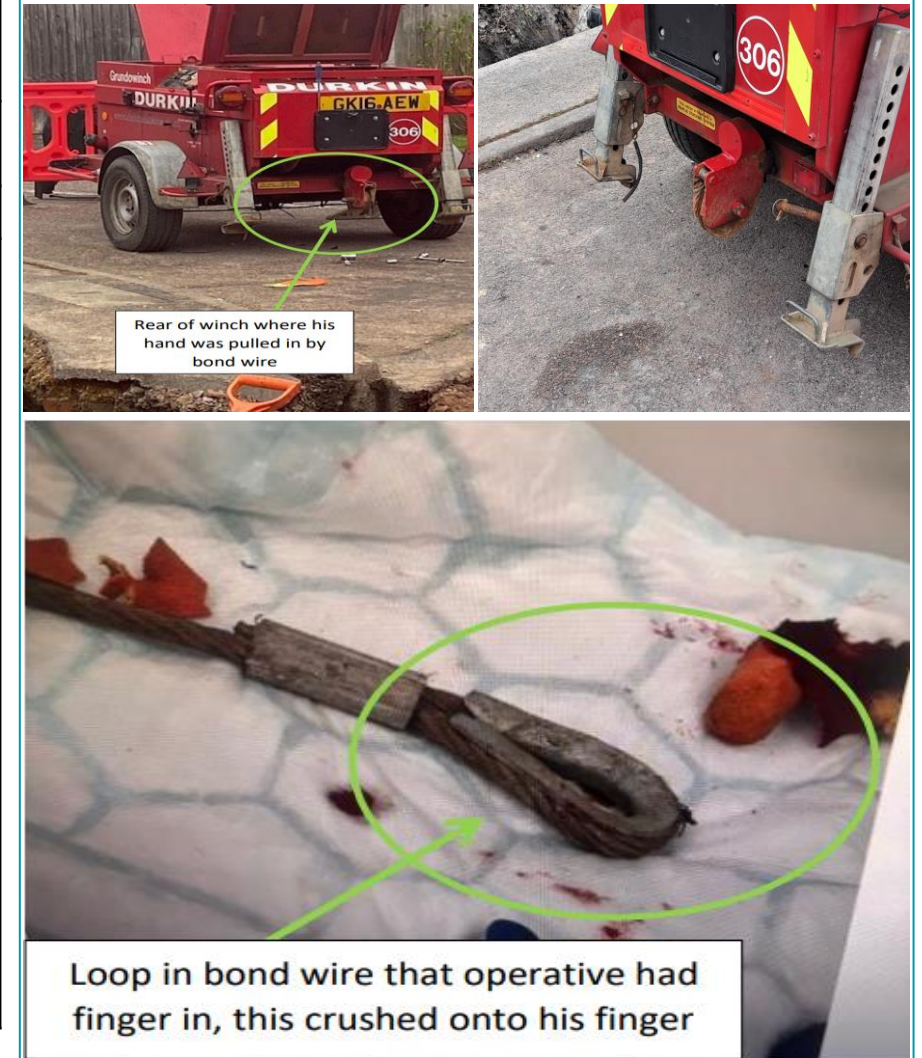
Date of incident which is raised in days	22 nd March 2024		Directorate	Operations SEPD	
Region	Works Delivery	Location	Church Crookham, Fleet	Classification	MTI
What happened ?					
<p>A contract partner was involved in a cable pulling operation. The winch was started while he was holding the bond wire with his finger through the eye loop at the end. Upon starting the winch, the bond auto-retracted pulling his right hand into the winch. The eye loop at the end of the winch was compressed onto his finger and his hand was trapped. Our contract partner received first aid on site and was taken to hospital where they received two stitches.</p> <p>Whilst we are investigating this incident it is important to remember to:</p> <ul style="list-style-type: none"> •Ensure you complete a risk assessment before completing all works. •Actively look for hazards and then manage the risks (Line of Fire, People/Plant Interface) •Always ask questions if something doesn't feel right - if it's not safe, we don't do it
