Safety Bulletin

Near Miss - Failure of Overhead Line Conductor Drum

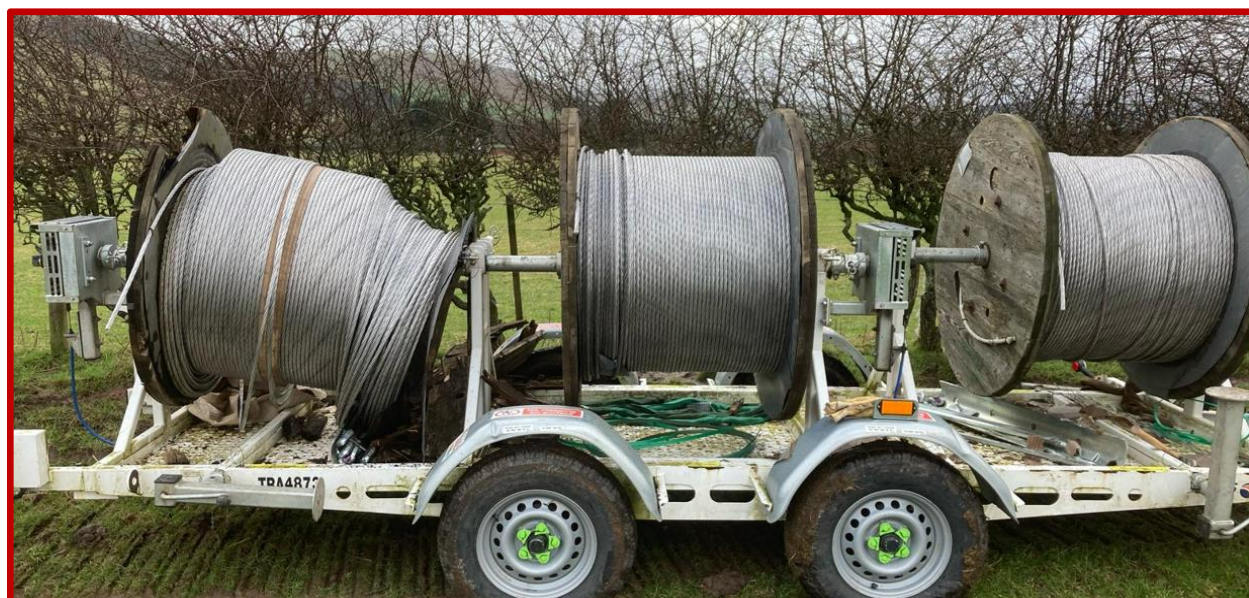
One of our overhead line teams were preparing to pull aluminium conductor from the back of a three drum trailer when one of the cable drums, weighing around 560kg structurally failed. Thankfully, none of our colleagues were in the 'line of fire' and no one was hurt. An image of the failed drum can be seen below.

The wooden drum failed due to severe timber rot. An examination of the drum after the failure showed that the rot was visible and evident.

Our conductor suppliers have processes in place to ensure that when drums are delivered to us, they are structurally sound. However, the failed drum had been delivered and stored outside at one of our depots for several years. Our logistics team have checked all conductor drums in the central warehouse and are checking drums stored at other logistics locations.

- Before handling or lifting conductor drums:
 - Always check each drum for signs of rot or structural damage.
- If you see or suspect rot or damage:
 - Place a warning notice on the drum.
 - Inspect other drums in the surrounding area.
 - Report it using the EcoOnline system.
- When handling or lifting conductor drums:
 - Create an exclusion zone around the lifting area.
 - Stay out of the 'line of fire'.
