Safety Action Notification

Plant & Machinery Movement

Location/Site: CAMBRIDGE COMPRESSOR STATION

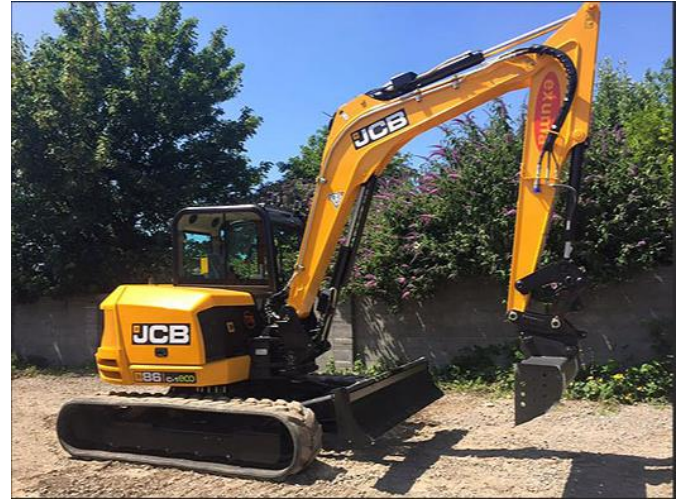
The digger driver reversed the 8-tonne excavator without using the reversing cameras or a banksman and crushed the pedestrian barriers that were moved out of the way to give his vehicle space to manoeuvre.

The Competent Person for this team had not provided a banksman at the rear of the vehicle and it appears the reversing camera wasn't used.

The pedestrian barriers were crushed under the tracks of the vehicle.

Sample Photo of 8 Tonne 360° Excavator

- In line with the new **7 Deadly Risks** campaign, where movement of plant & machinery is envisaged, **Use A Banksman**.
- Ensure all RAMS are reviewed to ensure that traffic management and plant movement is considered with relevant controls implemented.
- Ensure the **Life Saving Rules** are considered with regards to **Line of Fire** and the establishment of safety barriers and exclusion zones, where applicable.
