Safety Notice

Issue 13 | Rev 0 | August 2024

Powerco 11kV Conductor Brought Down by Helicopter

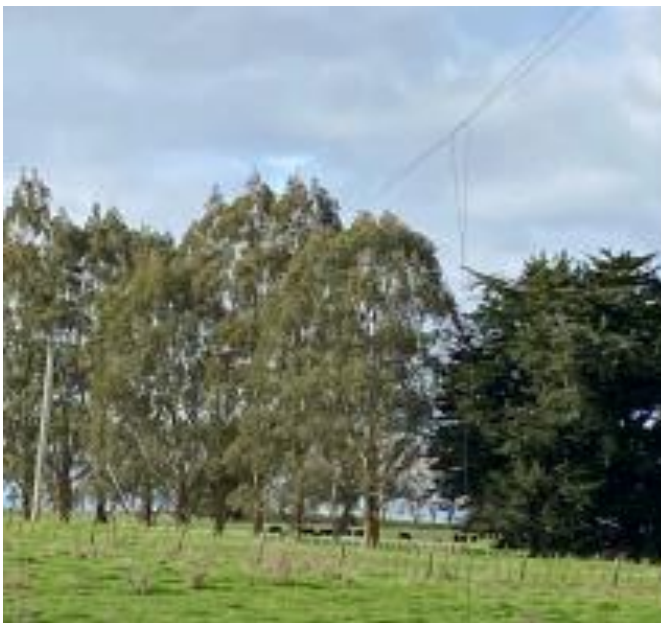
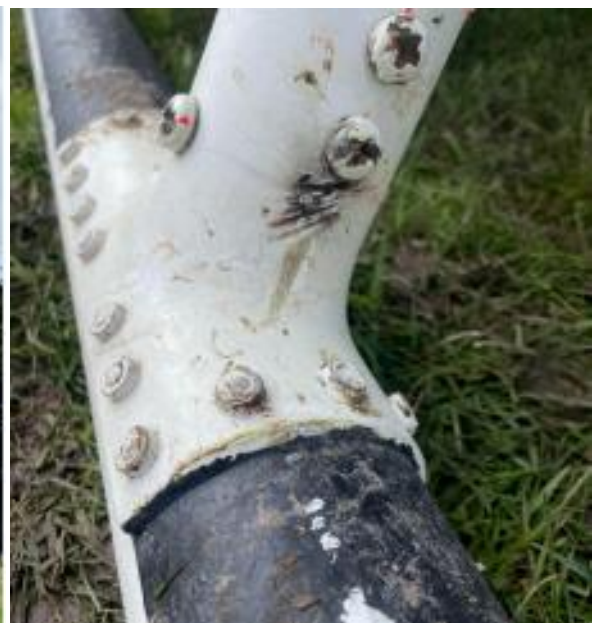
During a liquid fertilizer application flight, a helicopter's skid has hit and brought down a Powerco 11kV conductor at a farm in Taihape. The Pilot flying the helicopter had come over a treeline and didn't see the lines until he was nearly upon them. By the time he pulled up the skid had hit and broken one of the three lines. The helicopter was safe to land and only had minor surface damage (as pictured).

- Ensure the setup of planning systems (e.g. Tebula) are prioritised before commencing a job.
- Obtain GIS Viewer access for Powerco Lines info.
- Minimise safety critical tasks when considering multiple competing priorities (distractions).
