Conduit lifted in switchyard

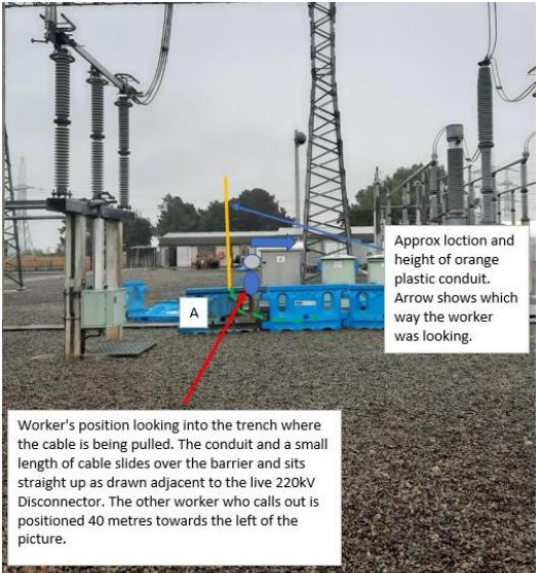
A project team were pulling back a 19-core control cable in a 1-metre concrete trench and had attached a section of 20mm 2.5m long plastic conduit to help direct the cable. Whilst pulling the new cable, a worker noticed the conduit bending upwards against a hard barrier that was above shoulder height and called out to the other team members.

Figure 1 - Yellow markup is simulating the conduit snake proximity to 220kv disconnector

Project team members did not control and monitor the end of the cable taped on to the conduit snake when it was pulled free from the trench and hit the blue barrier. They relied on gravity to hold the conduit at ground level.

- All equipment, plant, cable snakes, cables and conduits must be fully controlled in switchyards to ensure they do not rise up above head height or encroach the minimum approach distances for that switchyard.
- Consider blind spots, unintended consequences and request assistance when required.
