SAFETY ALERT 24/04

Steel pillars – livening hazard.

Critical risk – uncontrolled energy release

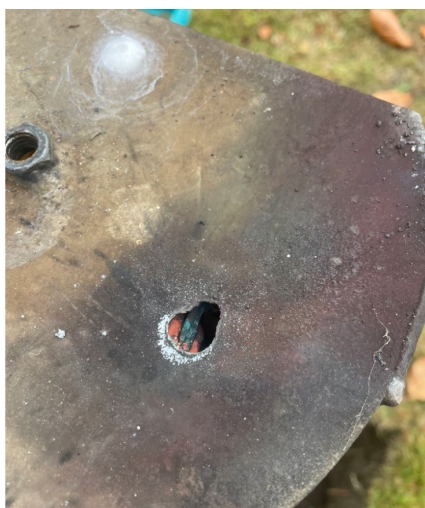
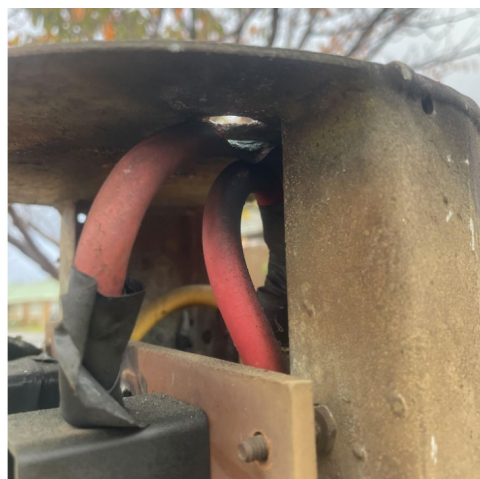
When removing the outer cover of a link pillar for replacement, cable jointers found a hole had been burnt through the top of the inner cover. Live wires have been in contact with the top plate and have melted.

It is most likely this pillar has been live, creating an electrocution/shock risk.

A risk of flash over is also present.

- **ALWAYS** - Test the pillar before touching or removing the cover.
- **ALWAYS** - Wear a flash visor and rated gloves (refer PPE standard 70001)
- Where required, isolate the circuit.
- Link pillars are particularly hazardous and additional precautions are required if working on these live. This includes use of cover up gear when working live.
- Refer LV Pillar Replacement Procedure.
