# Power Quality

John He – Graduate Electrical Engineer (Powerco Ltd)

1. LV overvoltage
2. Harmonics
3. Light flicker
4. Motor shorting
5. PQ monitoring of the Kapuni 11kV DG site

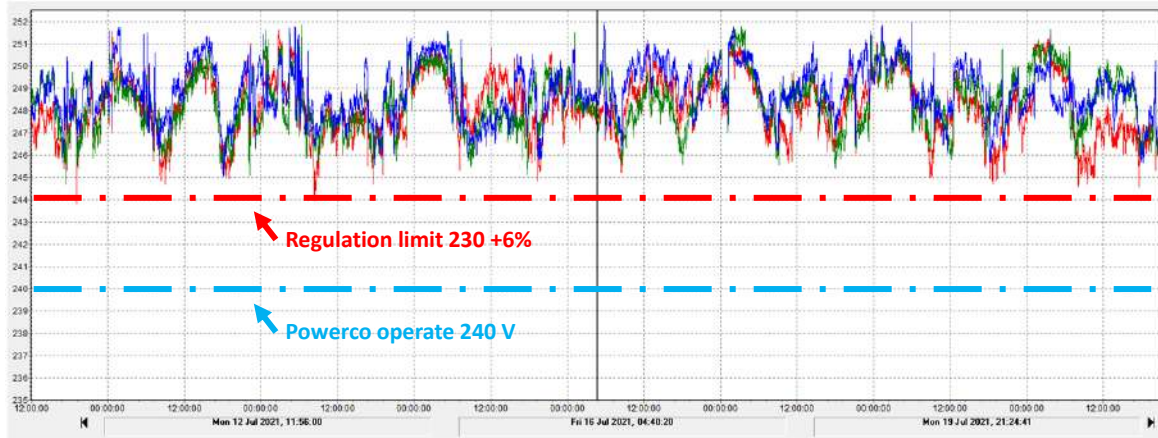
## 1.1 LV Overvoltage – Waveform

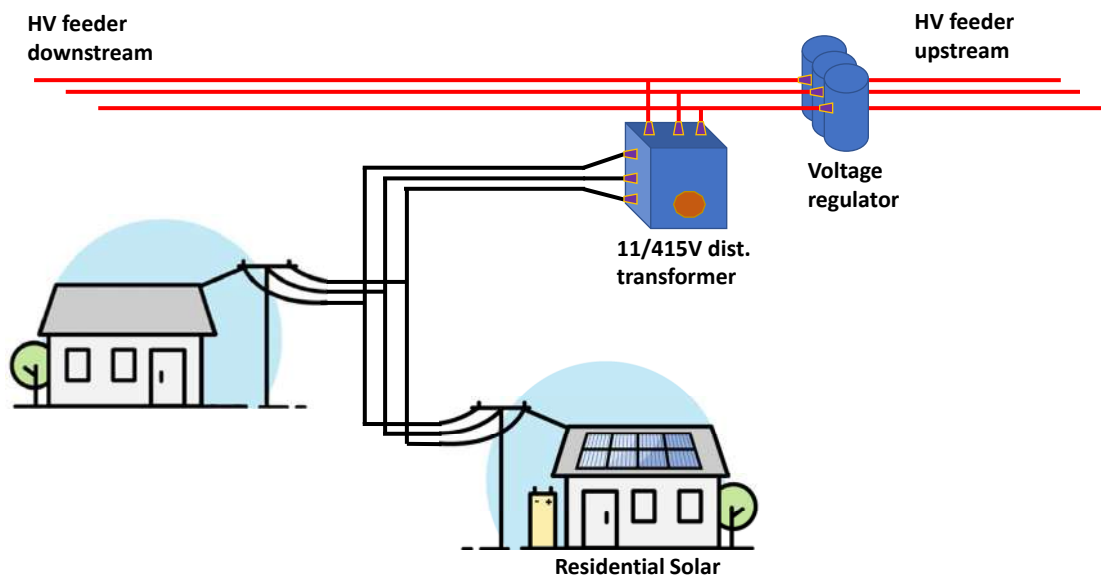
## 1.2 LV Overvoltage - Cause

## 1.3 Overvoltage - Solutions

- 1) Apply Line drop compensation at the voltage regulator
- 2) Perform tap change (tap up) on (or all) concerning dist. transformer
- 3) Check Volt-var, volt-watt setting on solar inverter is active

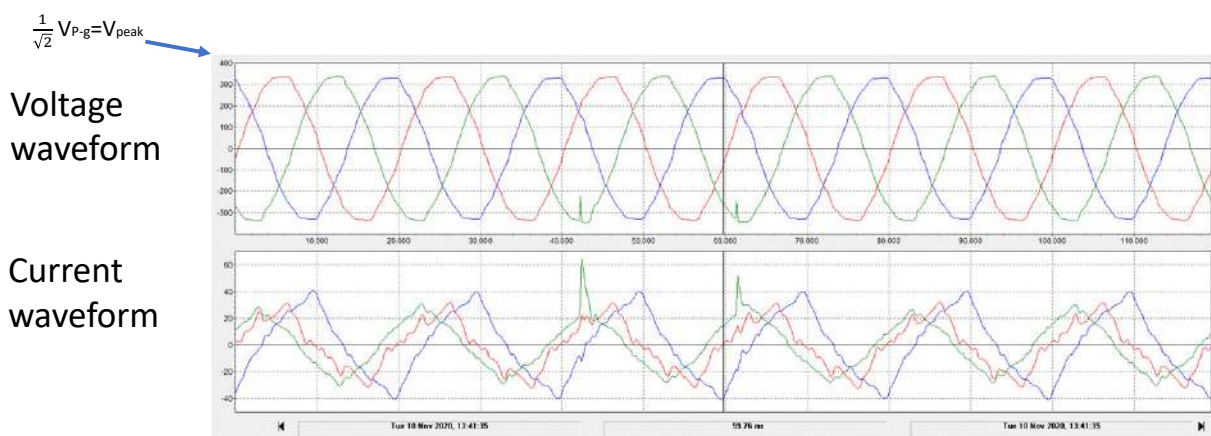
## 2.1 Harmonics – Waveform

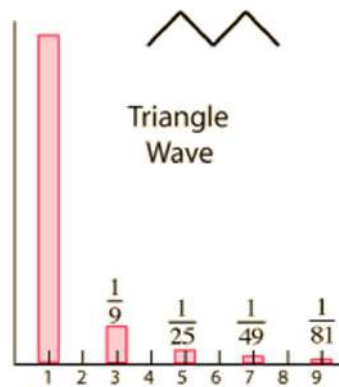
## 2.2 Harmonics – Cause

- $Z_h$  (system impedance) =  $Z_1 + Z_2 + Z_3 + Z_n$
- $V_d$  (voltage distortion) =  $V_1 + V_2 + V_3 + V_n$
- $I_d$  (current distortion) =  $I_1 + I_2 + I_3 + I_n$

$$V_d = I_d Z_h$$

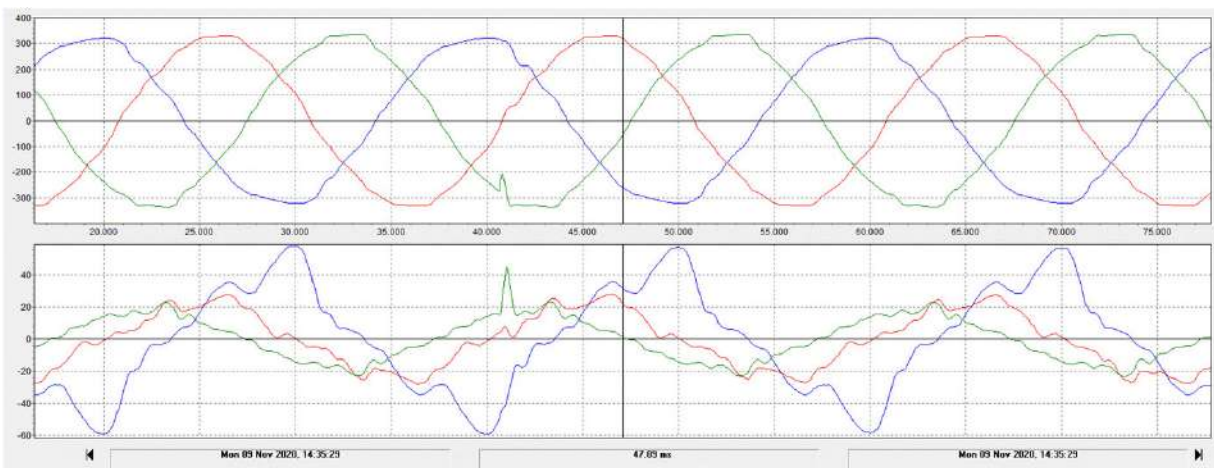
## 3.1 Light Flicker – Waveform

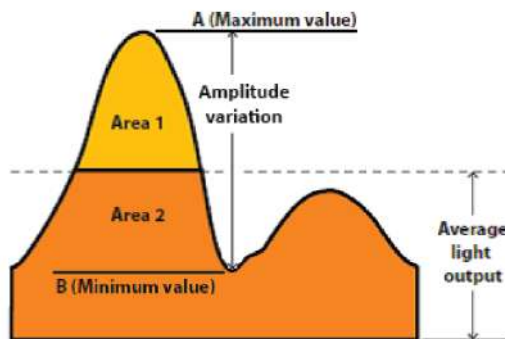
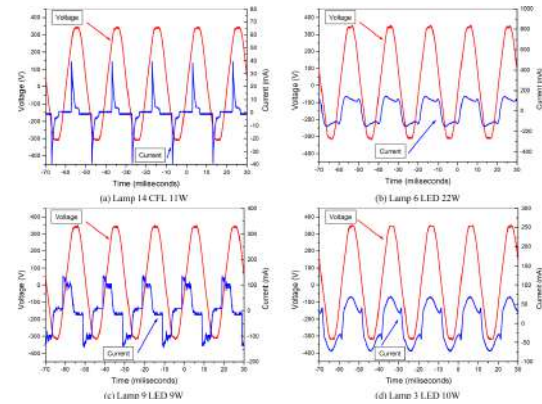
## 3.2 Light Flicker – Cause

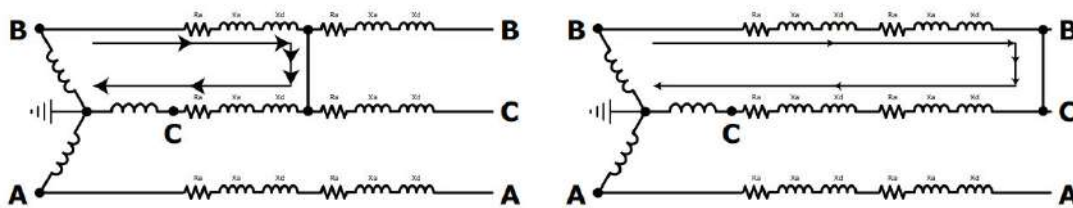
## 4.1 – Quick Intro to 2-Phase Faults

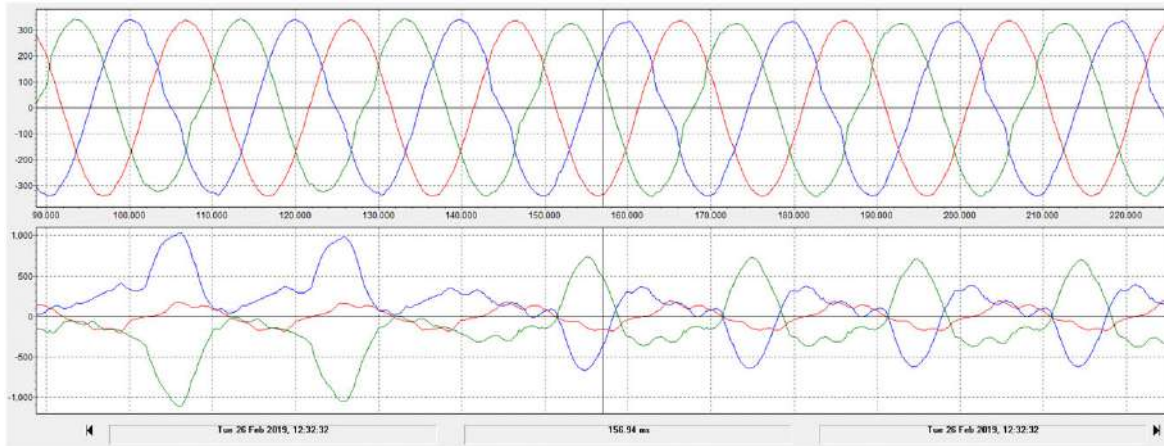
## 4.2 Motor Shorting -Waveform

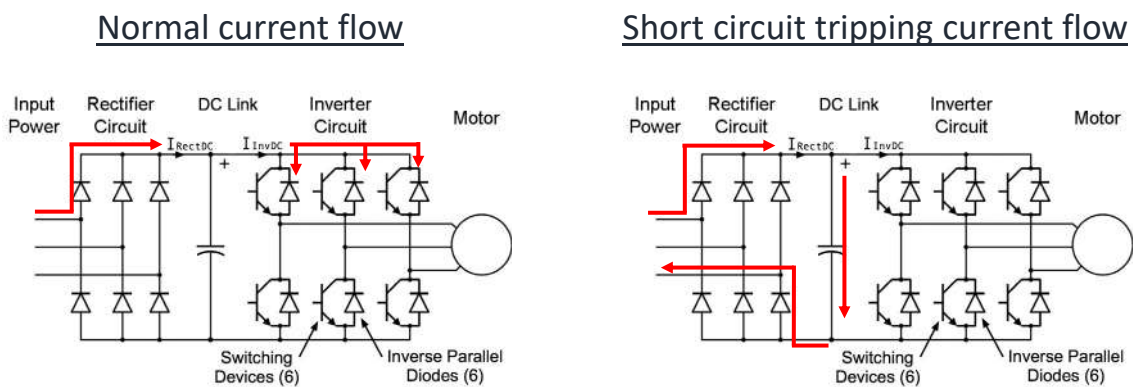
## 4.3 Motor Shorting - Cause

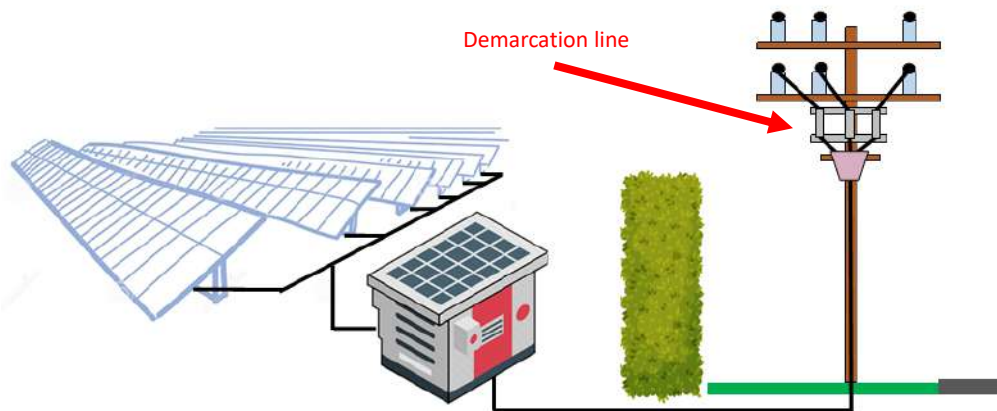
### 5.1 Present Solar Plant Connection to Network

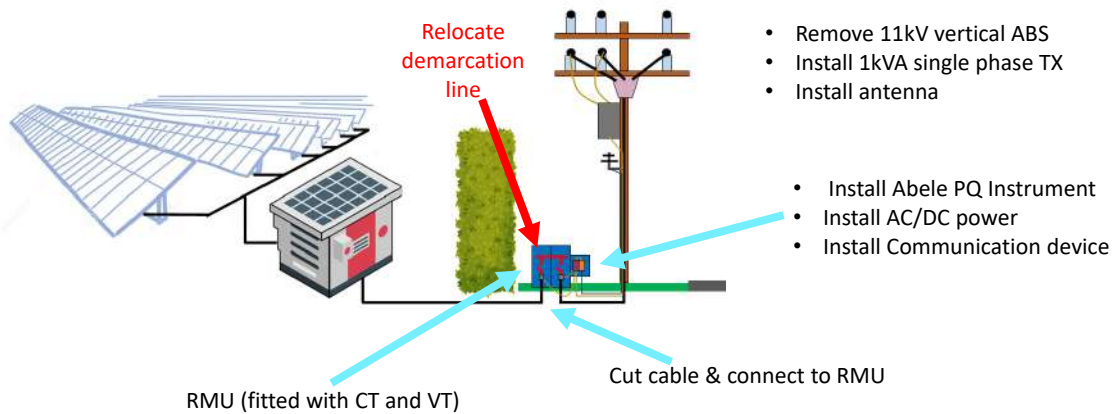
## 5.2 Proposed Network Change
