EEA OH Designers Forum – Christchurch, 3 August 2022

Reliability by design – separable connections on OH lines and what designers should be aware of

Goran Stojadinovic, MCE, MEE

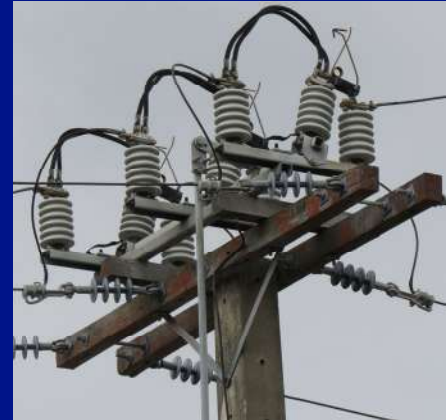
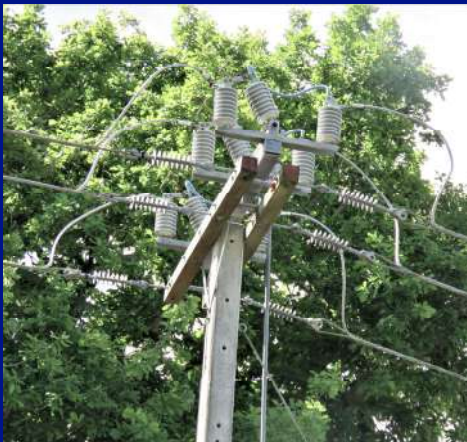
Conventional ABS

The flaw in the design - the spatial relation between contacts and pivoting insulator:

- **The pivoting insulator and the contact surfaces of the blade move in the same (vertical) plane e.g. they are parallel to each other**

- A sideways movement of the insulator causes equivalent vibrations of the blade/fork in the same direction, causing:
 - Fretting wear on one side
 - Micro-arcing, pitting, and erosion on the other side
 - Gets even worse with moisture, sea spray, pollution, thermal changes, galvanic processes...
 - Self-perpetuating

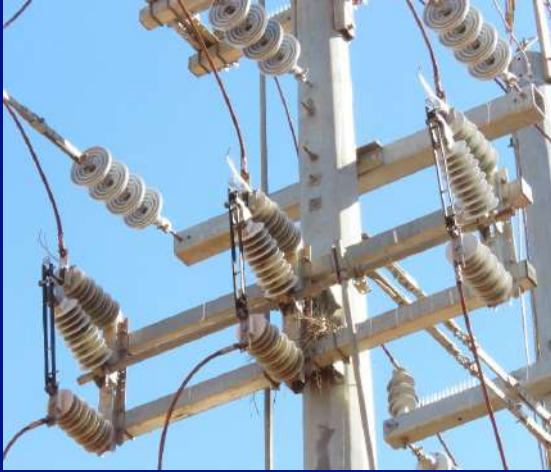
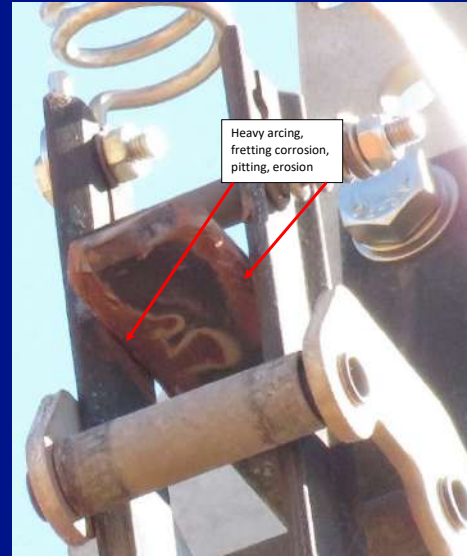
Real-life examples: A 33kV ABS on a line exposed to Aeolian vibrations

Heavy arcing, fretting wear, pitting, and erosion in less than a year in service

- The line is perpendicular to the steady wind
- Vibrations felt on the pole with a bare hand

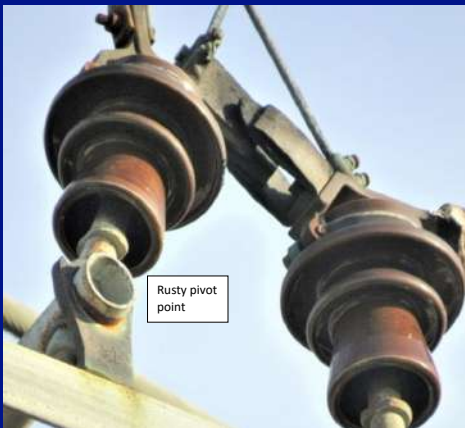
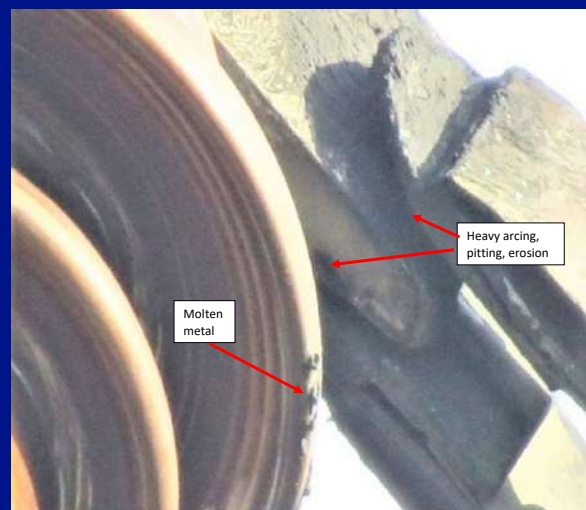
Real-life examples: 11kV ABS in a closed position

Heavy arcing, fretting wear, molten metal, pitting, and erosion of the main contacts

- The ABS along the main road
- Rusty pivot point (bushing)

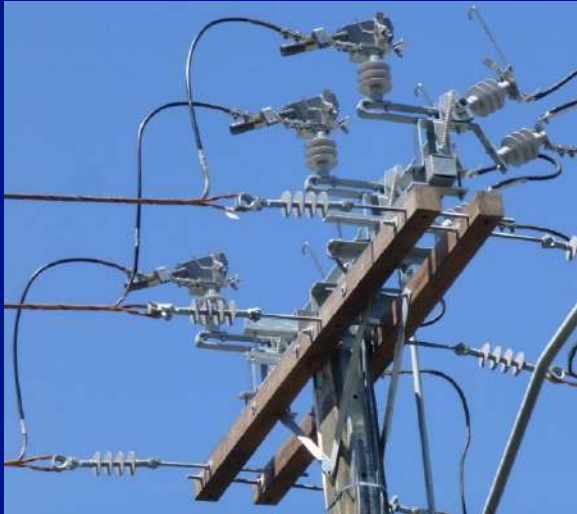
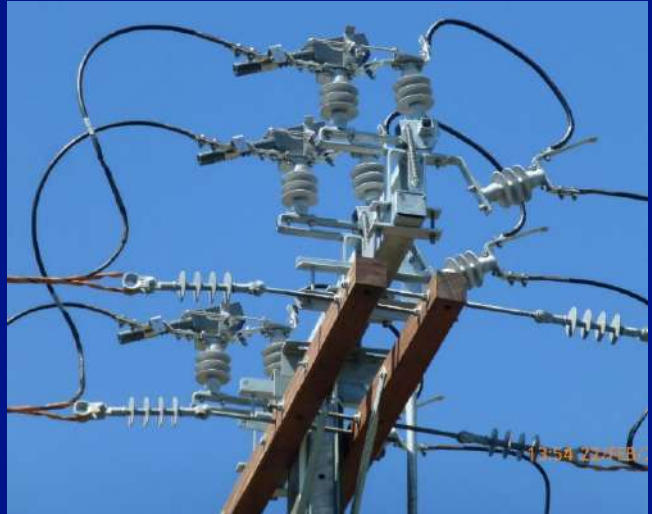
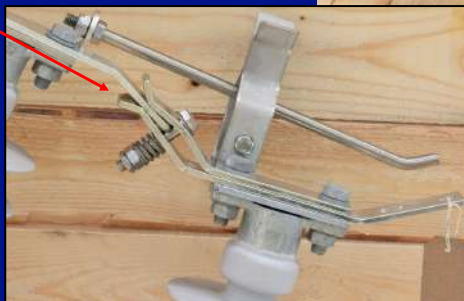
New design of ABS (Note: New to New Zealand)

The key difference

- The middle insulator and contacts are at 90° to each other (e.g. in different planes)
- Lateral vibration of the middle insulator won't affect the contact surfaces between the blade and fork
- If the insulator vibrates, the blade slides between the fork fingers – it does not hit the fork

Note:
The lateral sliding distance
is in μm and doesn't
affect the contacts

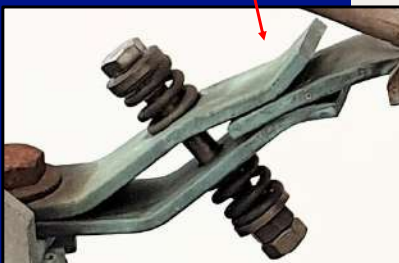
A picture is worth a thousand words – a recently replaced ABS with near-perfect contacts after 40 years in service
