Review of External Tank Foam Loss History

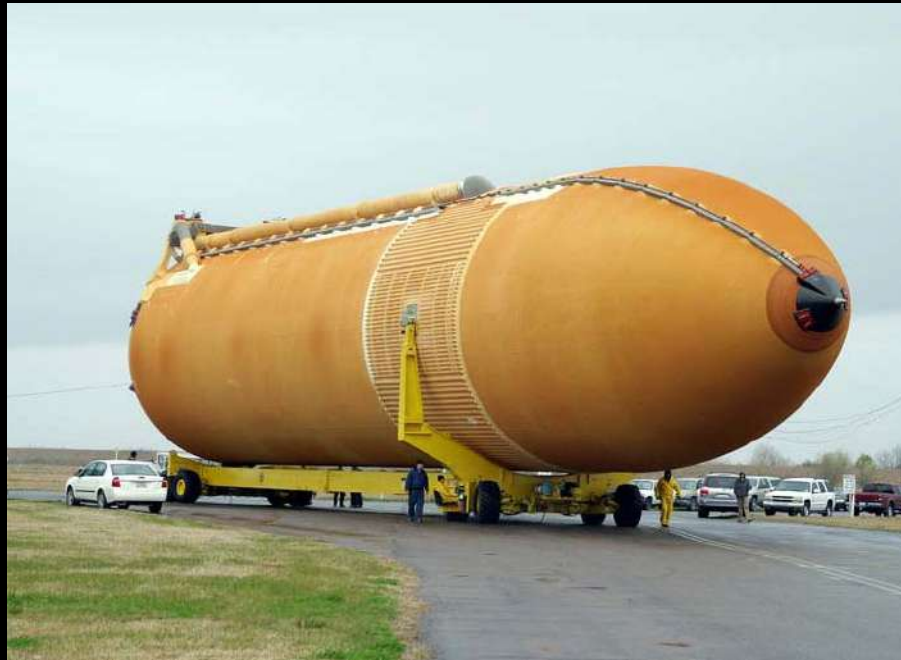
Slide 9

% of Flights with Observed TPS Loss *
LO2 Tank Acreage	1%
LH2 Tank Acreage	43%
Intertank Acreage	47%
Bipod Ramps	8%
LO2 Tank to Intertank Flange	0%
Intertank to LH2 Tank Flange	65%
Jack Pads	21%
LH2 PAL Ramp	3%
LO2 PAL Ramp	0%
Thrust Struts	23%
Vertical Struts	6%
LO2 Ice/Frost Ramps	5%
Intertank Ramps	0%
LH2 Ice/Frost Ramps	20%
Longeron	6%

*STS-112/ET-115
Bipod Ramp
Foam Loss*

*STS-87/ET-89 Intertank
Acreage Foam Loss*

*STS-51/ET-54
Intertank / LH2
Tank Flange and
LH2 Tank Acreage
Foam Loss*

* Based on Flights with Usable Imagery
