Live line OPGW refurbishment in an urban environment

Rex Inger*, Ian Hulme
Beca Ltd.

EEA Conference & Exhibition 2014, 18-20 June, Auckland

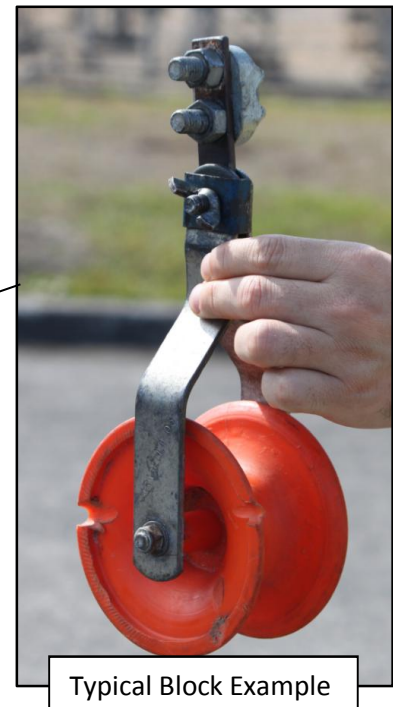
A CSS is a stringing system that can allow a conductor, or groundwire, to be supported during stringing without the need for netting/scaffolding, road closures or de-energising circuits. The support system is installed, in this case along the existing groundwire, using a motorised tug to pull out a support wire with blocks spaced at specified intervals. Once the support system is pulled out and secured to the towers, the new groundwire is connected to the existing groundwire and pulled through using the existing groundwire. If a failure occurs on the groundwire while it is being pulled out, it will be supported by the CSS to prevent it contacting any obstructions below.

- connect a motorised tug to the existing groundwire to pull out the CSS;
- tension the CSS to meet a specified sag and secure it to the towers;
- square rig the OPGW through the stringing tower and connect it to the existing groundwire;
- reduce the tension in the groundwire and use it to pull through the new OPGW;
- once the OPGW is pulled through, secure it to the tower and retract the CSS along the OPGW;
- sag the OPGW to design tensions
