Aeolian Vibration

Trial method

Conductor Modelling

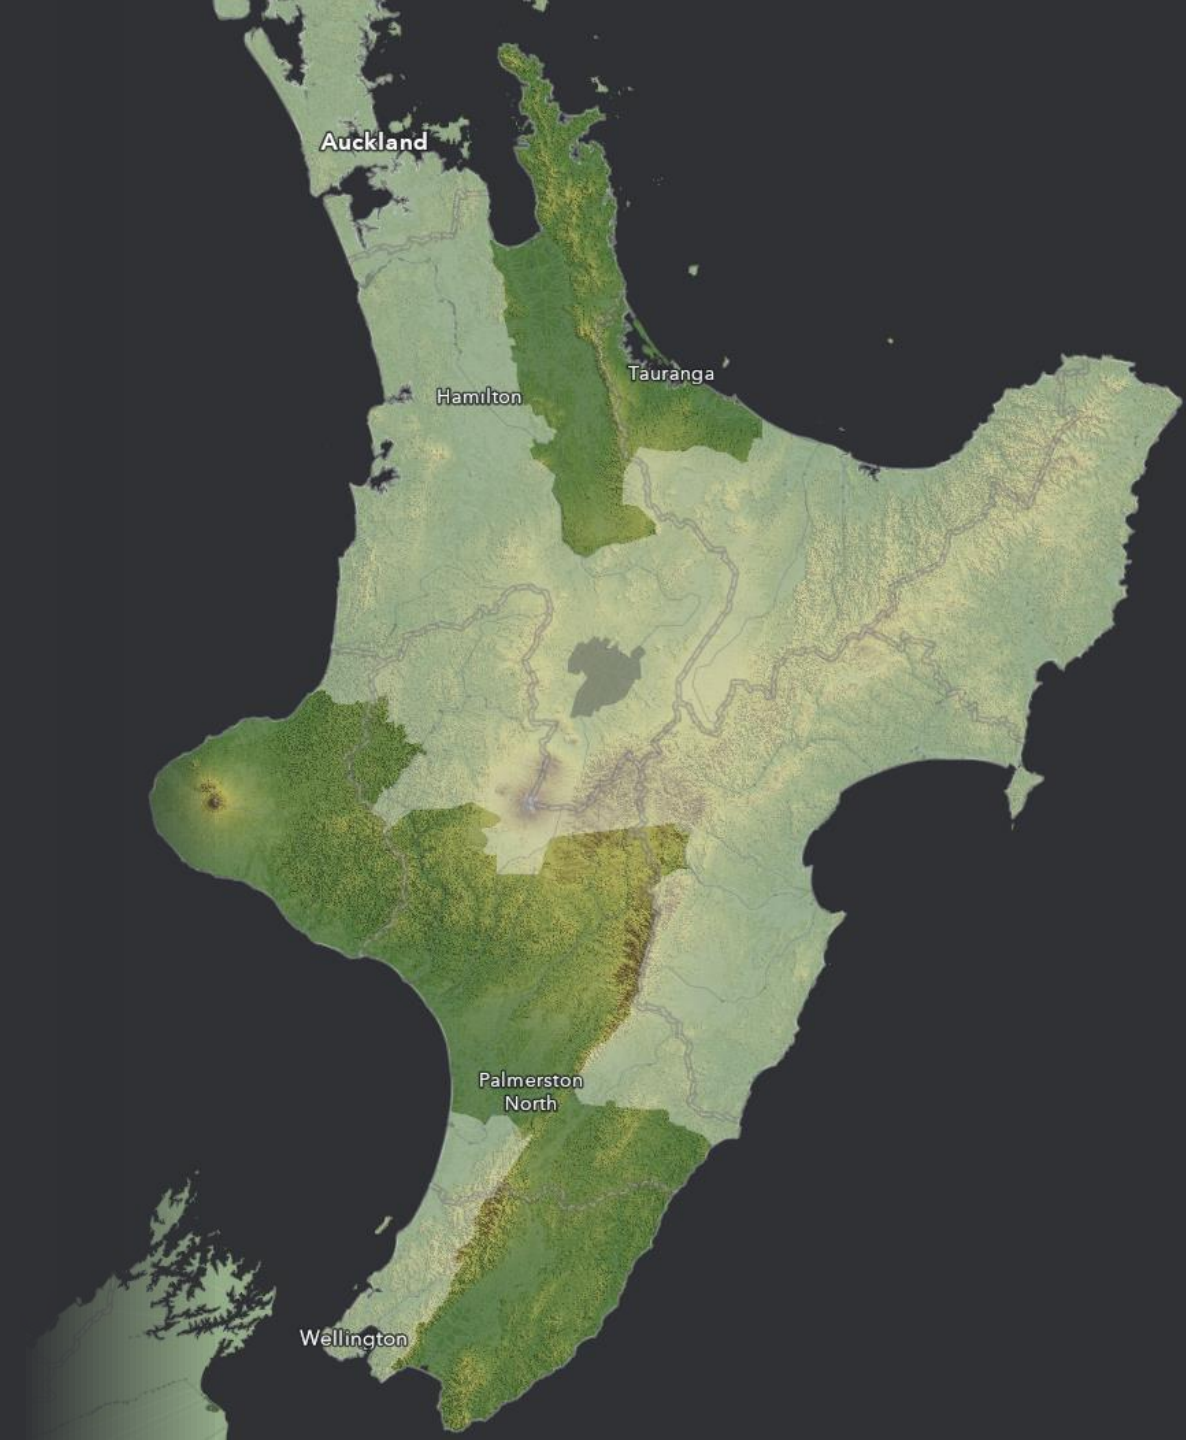
- Unknown locations
- Installing dampers is not feasible for entire network
- Seen damage
- Heard and seen the vibration

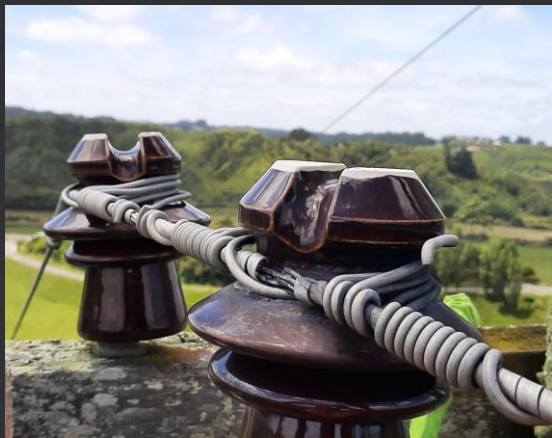
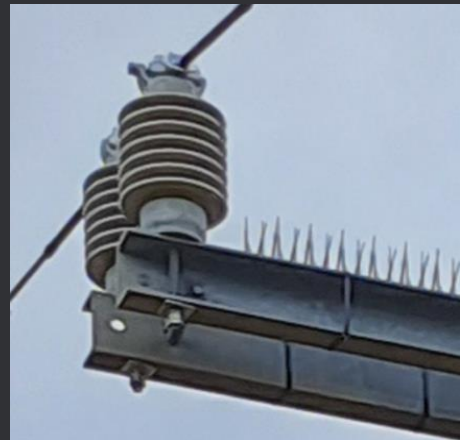
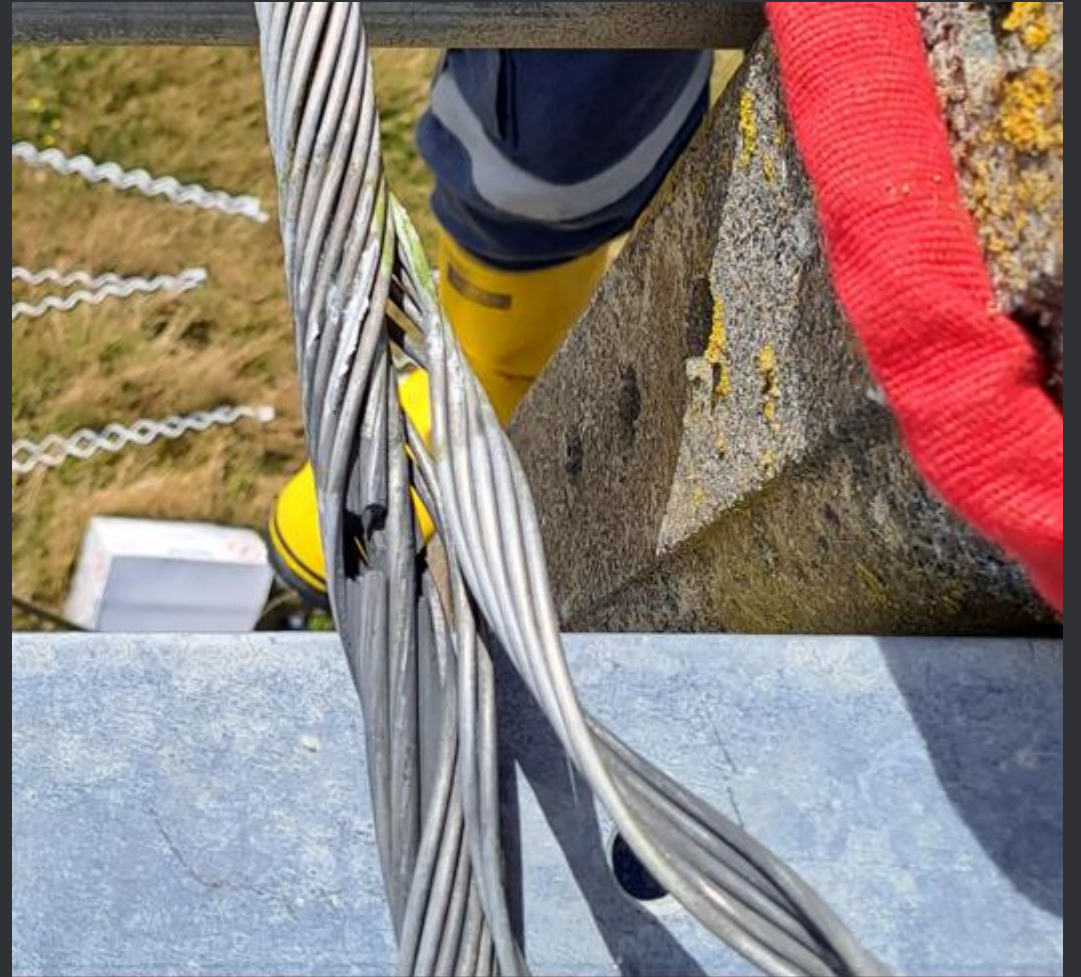
Damage Caused to Conductor

Damage occurs at intermediate structure attachment points that are clamped or tied where the conductor has an abrupt inability to flex.

The restrained movement at these points will fatigue and cause fretting of the conductor stands.

Fretting damage tends to occur on internal stands that are hidden by line guards & armour rods.

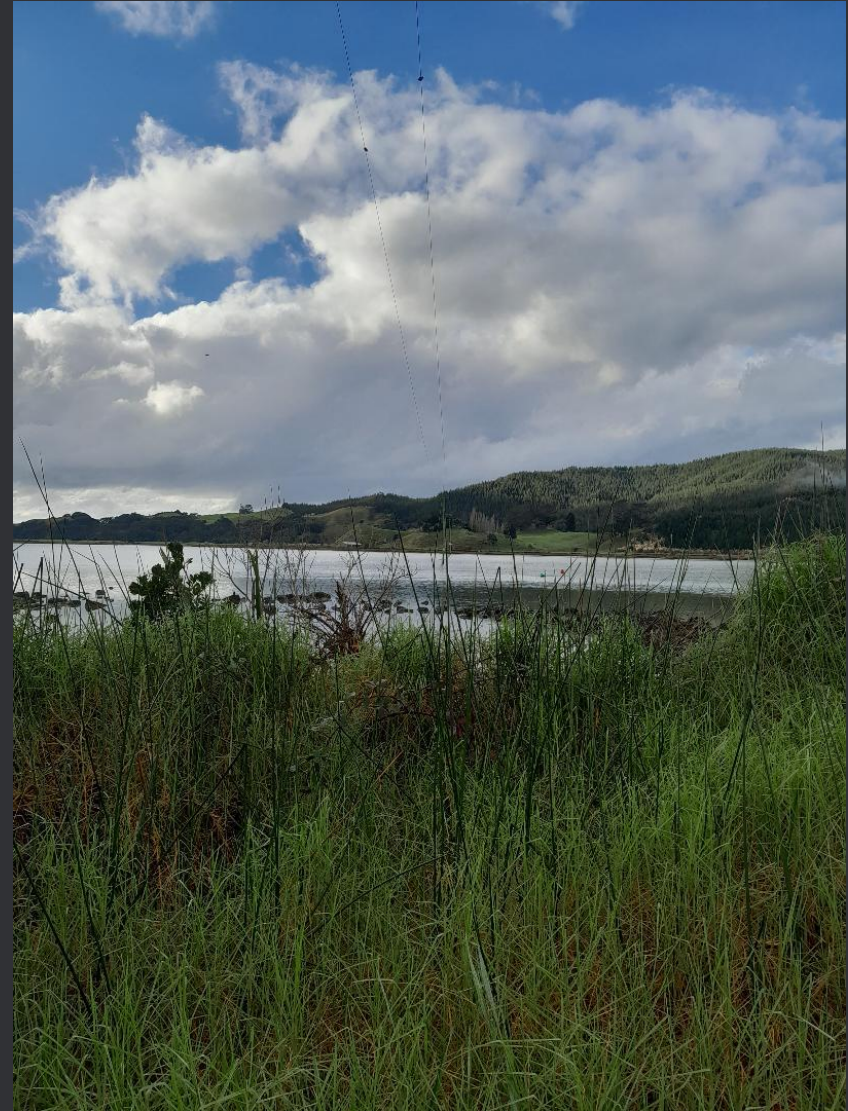
- Site selection
- Modelling presence of aeolian vibration
- Installing the vibration sensors and weather station
- Analysing the results

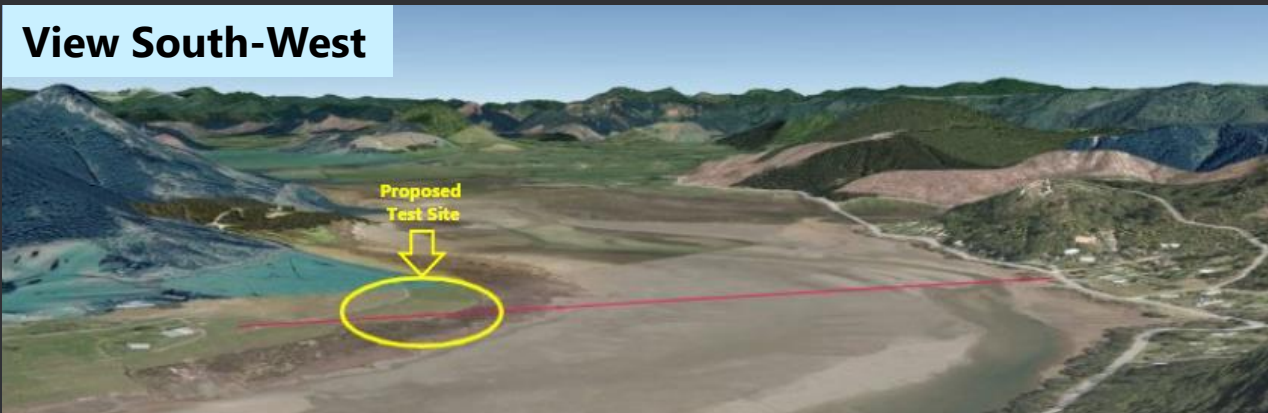
Vibration sensor trail location at Rangipo Road, Opoutere Beach- flat land and has a water body at high-tide

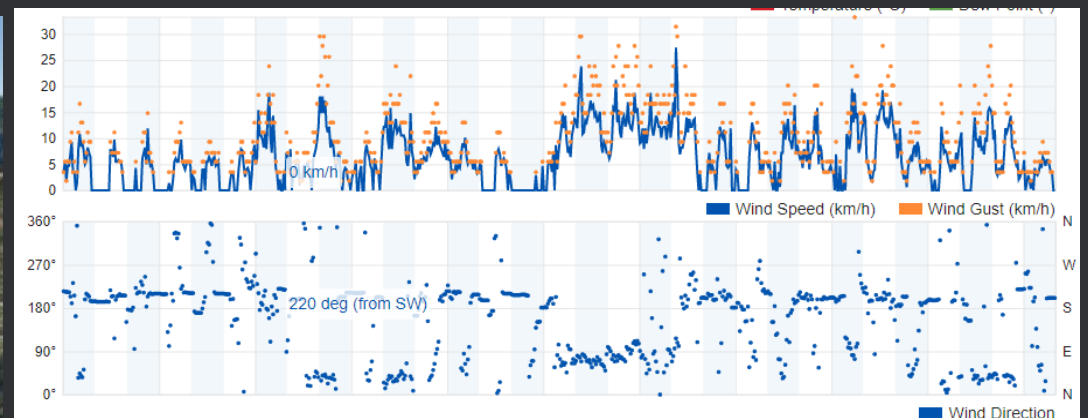
Historical weather data recorded at Rangipo Road, Opoutere Beach

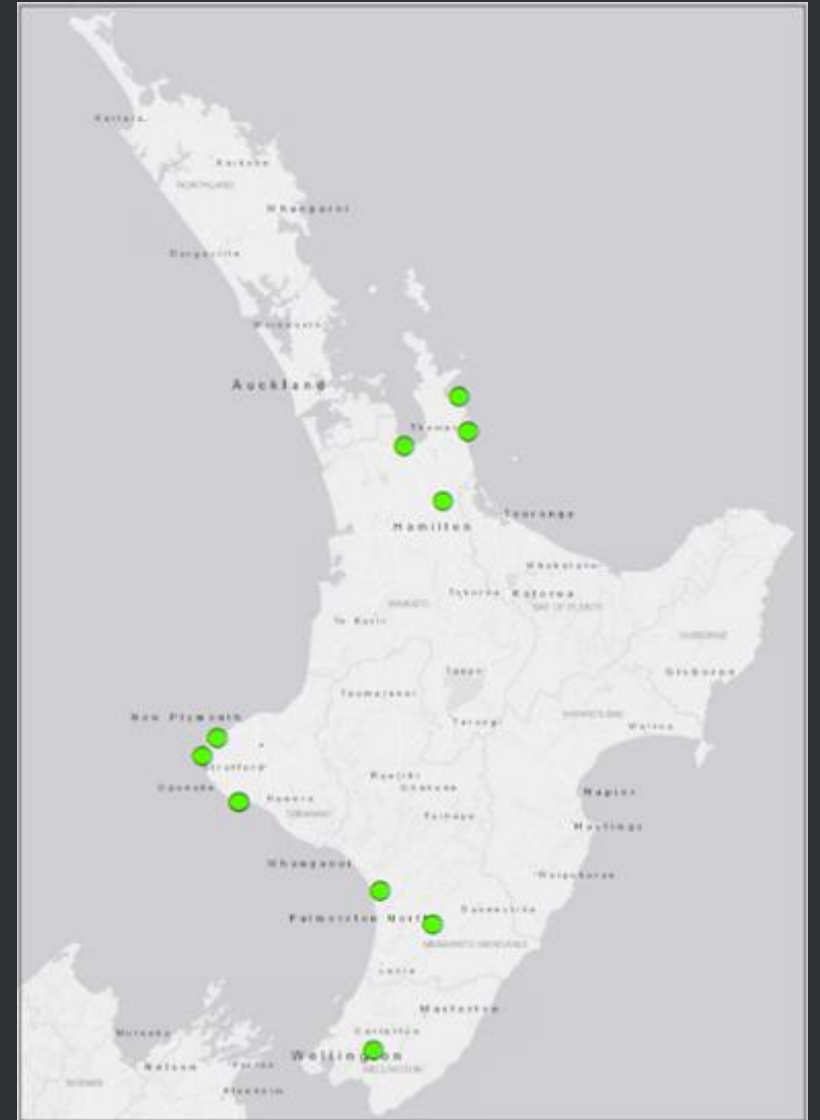
Ten selected vibration sensor trial locations

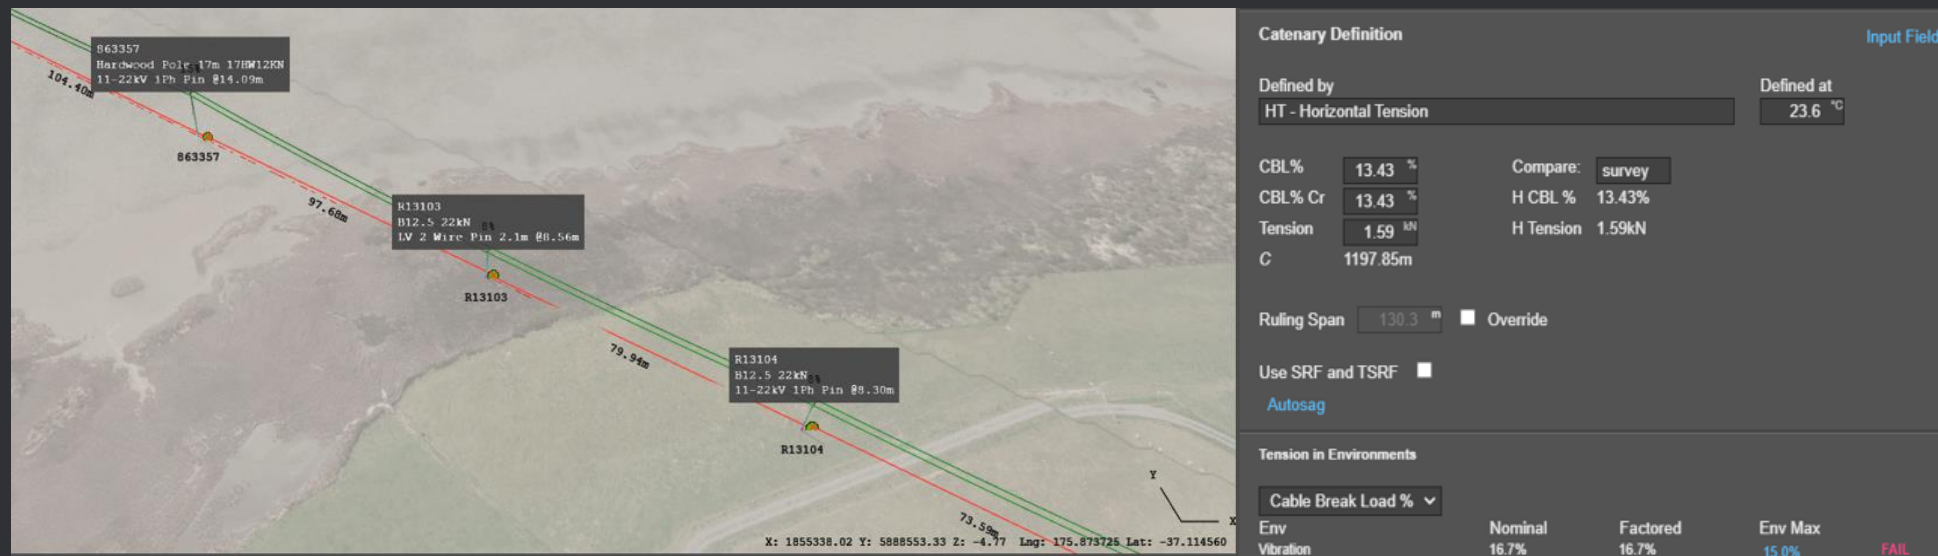
- Tensions were calculated from conductor sags captured during Lidar survey
- A vibration environmental load case was setup to model tension increasing during temperature changes
- The Rangipo Road model showed aeolian vibration is likely to occur when local temperatures fall below 11.7°C and tension increases above 16.5% CBL

Tension and environmental conditions likely to produce aeolian vibration

Modelling within overhead line design software

Trial Location:	Rangipo Road, Opoutere Beach
Pole ID's:	R13104 - R13103
Perpendicular Wind Directions:	NE or SW
Conductor Type:	AAAC Fluorine (7/3.00 stranding)
Lidar Capture Tension:	13.43%CBL at 23.6°C
Base Case Tension- Table Y1: (Clamp Category- Type B & Terrain Category- Type 1)	16.5%CBL
Likely occurrence of vibration:	<11.7°C
Local Minimum Temperatures:	0.7°C in October
Local Wind Speed Range:	1-7 m/s

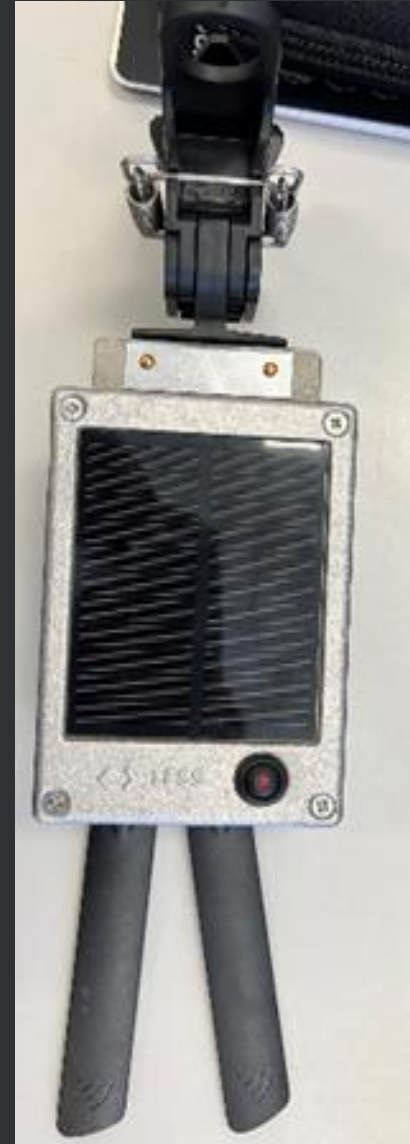
The monitors we have decided to use are capable of monitoring multiple situations, such as broken cables, fallen towers, strong winds, inclination and sag monitoring, and aeolian vibration.

The logger has the following features:

- Two solar panels
- Two antennas
- Snap fast clamps for easy installation on live lines

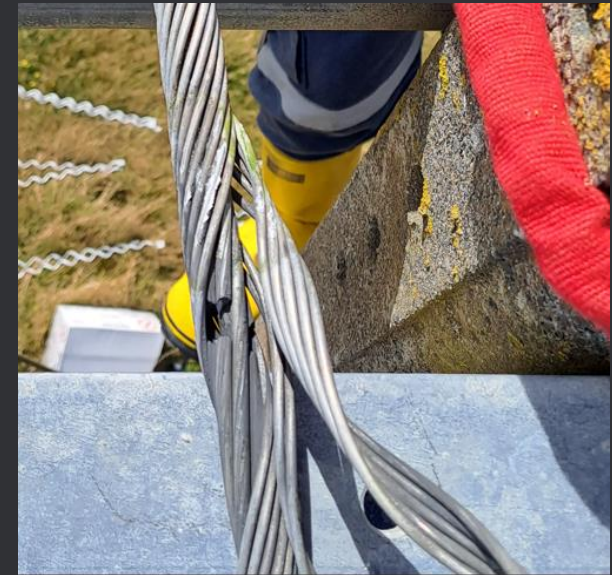
Aeolian vibration damage
