FIRST ALERT

07.02.2025

CB982A Y phase Failed During Operation

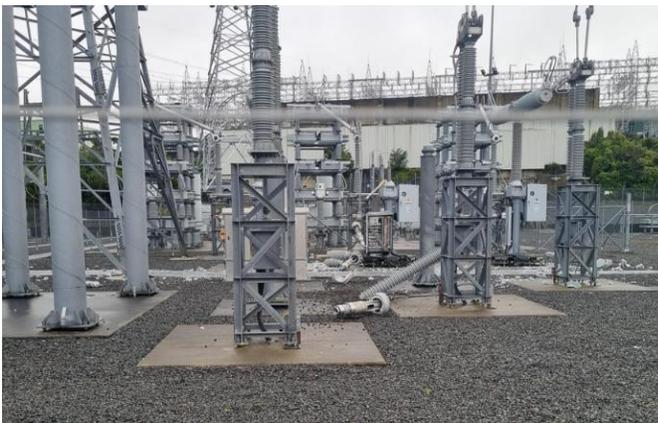
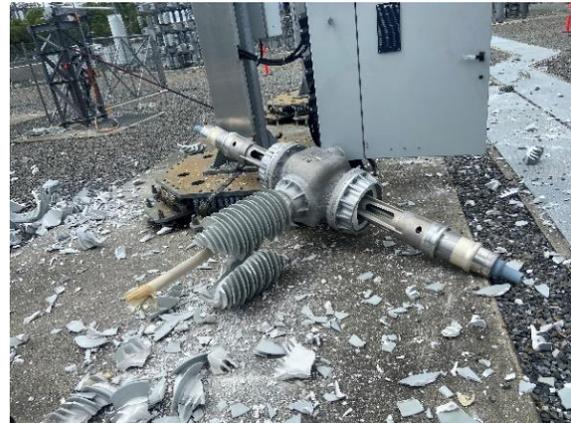
On 31.01.2025 at 06:08am Haywards Filter bank 5 tripped via protection operation. When staff arrived on site, they discovered HAY-CB-982A Y phase had suffered a catastrophic failure resulting in the loss of SF6, with porcelain and mechanical components dispersed across the filter bank switchyard.

The failed circuit breaker is a Siemens type 3AP2. These circuit breakers are associated with HVDC assets and are only installed at Haywards and Benmore Substations. The 3AP2 circuit breaker is an SF6 circuit breaker with double head/interrupter arrangement.

- Investigation has commenced.
- The immediate areas around the 3AP2 type circuit breakers at Haywards and Benmore, have been cordoned off and are restricted access areas until further notice.
- The concern relates only to Siemens type 3AP2 circuit breakers. Transpower is engaging NZ subject matter experts and Siemens Original Equipment Manufacturer (OEM) for advice.
